Access Compliance Report

Public Rights-of-Way

(Curb Ramps)

Intersection ID: 13085	Main Street: MORRIS_FIELD_DR	Cross Street: CAPITOL_DR	Location: S
ADA ID: 791FEE4174A2	Ramp Type: Combination2	Initial Pass/Fail: Fail	Overall Compliance: No
			Severity Score: 46.25

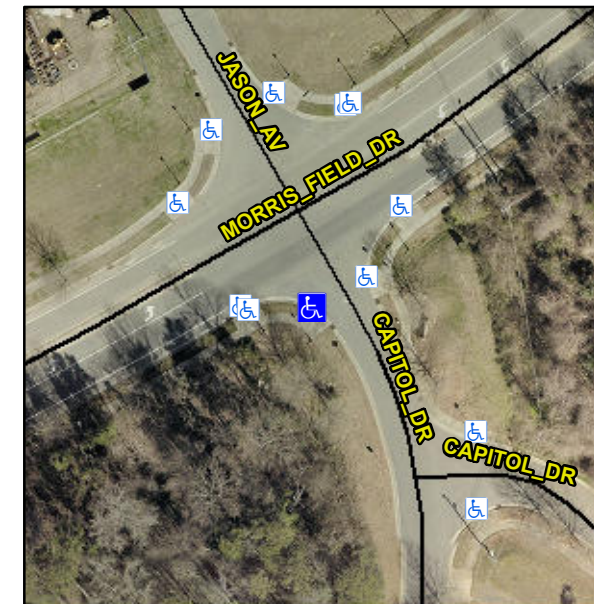
R304.5.1, R304.5.3, R304.3.2

Compliance	Description	Data	Compliance	Description	Data
N/A	Ramp Length LT (in)	61.0	N/A	Ramp Length RT (in)	N/A
Yes	Ramp Width LT (in)	72.0	N/A	Ramp Width RT (in)	N/A
No	Ramp Slope LT (%)	12.2	N/A	Ramp Slope RT (%)	N/A
No	Ramp XSlope LT (%)	2.1	N/A	Ramp XSlope RT (%)	N/A
N/A	Ramp Length (in)	72.0	Yes	Ramp Slope (%)	6.2
No	Ramp Width (in)	47.0	No	Ramp XSlope (%)	5.7
N/A	Flare Type LT	N/A	N/A	Flare Type RT	N/A
N/A	Flare Slope LT (%)	N/A	N/A	Flare Slope RT (%)	N/A
N/A	Flare Traversable LT?	N/A	N/A	Flare Traversable RT?	N/A
N/A	Landing Length (in)	N/A	N/A	DWS Provided?	N/A
N/A	Landing Width (in)	N/A	N/A	DWS Contrast?	N/A
N/A	Landing Slope (%)	N/A	N/A	DWS Length (in)	N/A
N/A	Landing X Slope (%)	N/A	N/A	DWS Full Width?	N/A
N/A	Landing Curb? (Y/N)	N/A	N/A	DWS Offset (in)	N/A
N/A	Shared Landing?	N/A			
N/A	Gutter Ponding?	N/A	N/A	Gutter Slope (%)	N/A
N/A	Gutter Lip Ht (in)	N/A	N/A	Gutter X Slope (%)	N/A
N/A	Painted X Walk1?	No	N/A	Painted X Walk2?	N/A

X Walk 1 Direction	To NE		X Walk 2 Direction	N/A
	X Walk 1 Width (in)	N/A		X Walk 2 Width (in)	N/A
	X Walk 1 Slope (%)	3.8		X Walk 2 Slope (%)	N/A
	X Walk 1 X Slope (%)	3.9		X Walk 2 X Slope (%)	N/A
N/A	Ramp inside XWalk1?	N/A	N/A	Ramp inside XWalk2?	N/A
	Road Slope (%)	N/A		Clear Space?	N/A
	Road X Slope (%)	N/A	N/A	Clear Space to XWalk (in)	N/A
			N/A	Any Obstruction?	N/A
				Obstruction Type	N/A
			N/A	Storm Grate/Utility Hazard?	N/A
				Storm Grate/Utility Type	N/A
					N/A
Yes	Surface Condition? (G/P)	Good			
	Curb Slope (%)	3.9

Remove & Replace Entire Ramp.
