Access Compliance Report

Public Rights-of-Way

(Curb Ramps)

Intersection ID: 5758	Main Street: NEVIN_RD	Cross Street: SPANISH_MOSS_LN	Location:	N
ADA ID: 7AAFCA45B513	Ramp Type: Perp	Initial Pass/Fail: Fail	Overall Compliance: No	Severity Score: 10

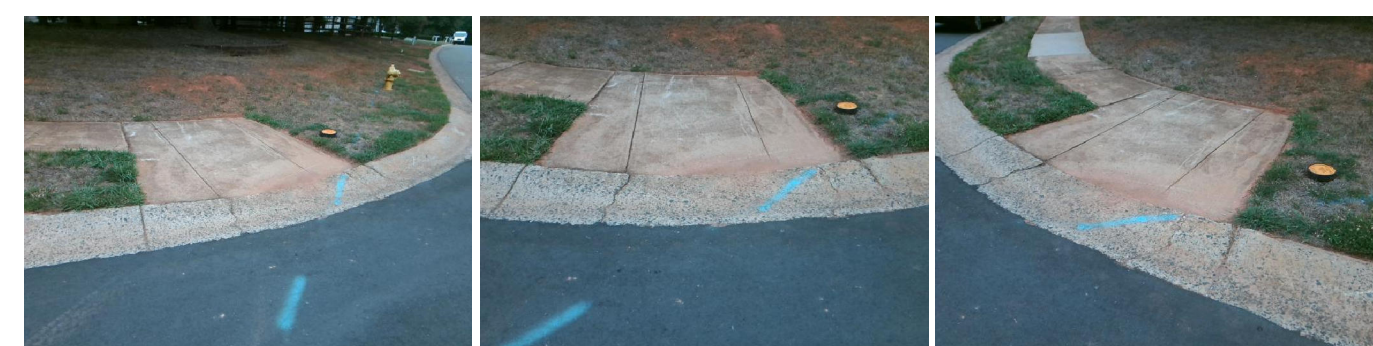
Possible Solutions:		Compliance	Description	Data	Compliance	Description	Data
	Remove & Replace Entire Ramp.		N/A	Ramp Length (in)	95.0	Yes	Ramp Slope (%)	7.4
			No	Ramp Width (in)	46.0	Yes	Ramp XSlope (%)	2.3
			N/A	Flare Type LT	N/A	N/A	Flare Type RT	N/A
			N/A	Flare Slope LT (%)	N/A	N/A	Flare Slope RT (%)	N/A
			N/A	Flare Traversable LT?	N/A	N/A	Flare Traversable RT?	N/A
			N/A	Landing Length (in)	N/A	N/A	DWS Provided?	N/A
			N/A	Landing Width (in)	N/A	N/A	DWS Contrast?	N/A
			N/A	Landing Slope (%)	N/A	N/A	DWS Length (in)	N/A
			N/A	Landing X Slope (%)	N/A	N/A	DWS Full Width?	N/A
Surveyor Notes:			N/A	Landing Curb? (Y/N)	N/A	N/A	DWS Offset (in)	N/A
N/A			N/A	Shared Landing?	N/A			
PROW/ADA:			N/A	Gutter Ponding?	N/A	N/A	Gutter Slope (%)	N/A
Not Found, R304.5.1			N/A	Gutter Lip Ht (in)	0.75	N/A	Gutter X Slope (%)	N/A

N/A	Painted X Walk1?	Yes	N/A	Painted X Walk2?	N/A
				X Walk 1 Direction	To S		X Walk 2 Direction	N/A
			N/A	X Walk 1 Width (in)	72.0	N/A	X Walk 2 Width (in)	N/A
				X Walk 1 Slope (%)	1.9		X Walk 2 Slope (%)	N/A
				X Walk 1 X Slope (%)	2.8		X Walk 2 X Slope (%)	N/A
			N/A	Ramp inside XWalk1?	Yes	N/A	Ramp inside XWalk2?	N/A
				Road Slope (%)	N/A	N/A	Clear Space?	N/A
				Road X Slope (%)	N/A	N/A	Clear Space to XWalk (in)	N/A
			N/A	Any Obstructions?	N/A	N/A	Storm Grate/Utility Hazard?	N/A
				Obstruction Type			Storm Grate/Utility Type	
					N/A			N/A
						Yes	Surface Condition? (G/P)	Good
