# Access Compliance Report

## Public Rights-of-Way

### (Curb Ramps)

| Intersection ID: 12342 | Main Street: E_8TH_ST | Cross Street: N_CALDWELL_ST | Location: E |

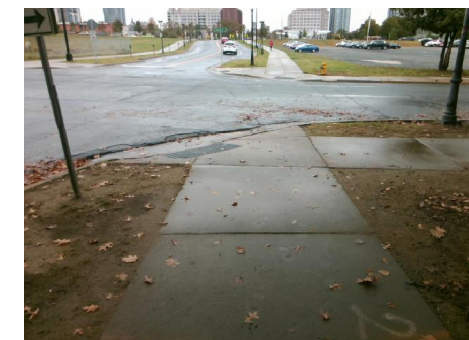
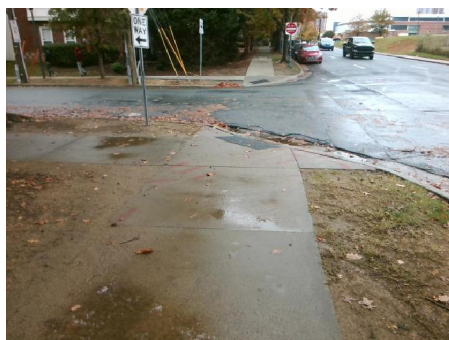
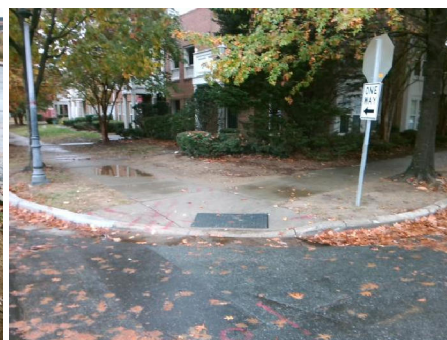
| ADA ID: 7AB9C586BF39 | Ramp Type: PerpDiag | Initial Pass/Fail: Fail | Overall Compliance: No |

**Not Found, R304.2.2**

| Compliance | Description | Data | Compliance | Description | Data |
|---|---|---|---|---|---|
| N/A | Ramp Length (in) | 46.0 | No | Ramp Slope (%) | 8.7 |

**Remove & Replace Curb Ramp With Two New Directional Ramps or Equivalent.**
