Access Compliance Report

Public Rights-of-Way

(Curb Ramps)

Intersection ID: 9061	Main Street: LUCENA_ST	Cross Street: NORRIS_AV	Location: E
ADA ID: 7AC9E3BBA17E	Ramp Type: ParaDiag	Initial Pass/Fail: Pass	Overall Compliance: No
Severity Score: 7.5			
Codes/Mitigation Info/Possible Solution		Field Measurements/Component Compliance

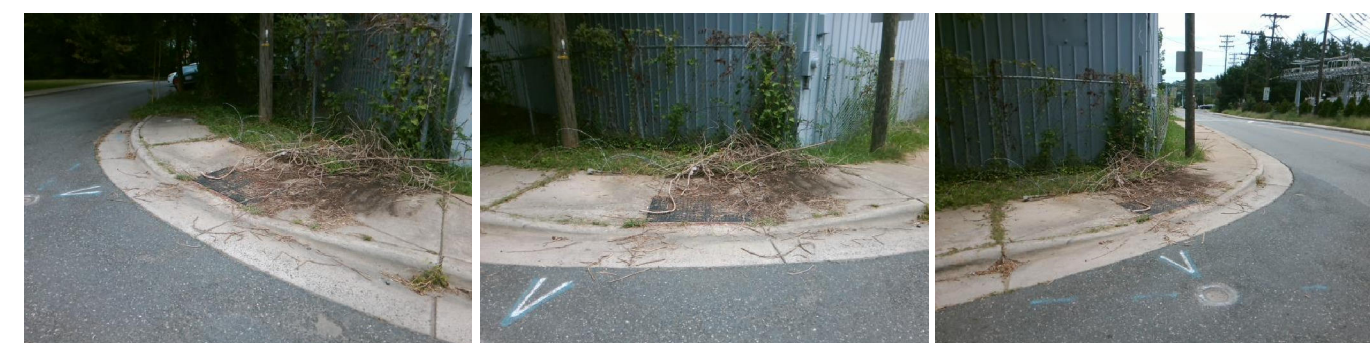
DEBRIS COVERING RAMP, LT RP < 5%

Not Found, R304.2.1, R304.2.2-Perp, R304.3.2-Para, R302.7, R302.7.2

Compliance	Description	Data	Compliance	Description	Data
N/A	Ramp Length LT (in)	57.0	N/A	Ramp Length RT (in)	60.0
Yes	Ramp Width LT (in)	59.0	Yes	Ramp Width RT (in)	57.0
Yes	Ramp Slope LT (%)	3.3	Yes	Ramp Slope RT (%)	5.7
Yes	Ramp XSlope LT (%)	1.8	Yes	Ramp XSlope RT (%)	0.6
Yes	Landing Length (in)	60.0	Yes	DWS Provided?	Yes
No	Landing Width (in)	42.5	Yes	DWS Contrast?	Yes
No	Landing Slope (%)	2.9	Yes	DWS Length (in)	25.5
Yes	Landing X Slope (%)	0.1	Yes	DWS Full Width?	Yes
N/A	Landing Curb? (Y/N)	No	Yes	DWS Offset (in)	2.0
N/A	Shared Landing?	No			
No	Gutter Ponding?	Yes	Yes	Gutter Slope (%)	5.0
No	Gutter Lip Ht (in)	0.5	Yes	Gutter X Slope (%)	0.5
N/A	Painted X Walk1?	No	N/A	Painted X Walk2?	No
	X Walk 1 Direction	To NW		X Walk 2 Direction	To SW
N/A	X Walk 1 Width (in)	N/A	N/A	X Walk 2 Width (in)	N/A
	X Walk 1 Slope (%)	0.6		X Walk 2 Slope (%)	1.2
	X Walk 1 X Slope (%)	2.1		X Walk 2 X Slope (%)	1.6
N/A	Ramp inside XWalk1?	N/A	N/A	Ramp inside XWalk2?	N/A

Road Slope (%)	0.2	N/A	Clear Space?	Yes
	Road X Slope (%)	3.9	N/A	Clear Space to XWalk (in)	N/A
Yes	Any Obstructions?	No	Yes	Storm Grate/Utility Hazard?	No
	Obstruction Type			Storm Grate/Utility Type	
		N/A			N/A
			Yes	Surface Condition? (G/P)	Good
			Replace	Curb Slope (%)	25.6

Remove & Replace Curb Ramp With Two New Directional Ramps or Equivalent.
