Access Compliance Report

Public Rights-of-Way

(Curb Ramps)

| Intersection ID: 48516 | Main Street: GALLERIA CLUB LN | Cross Street: GALLERIA BV | Location: NE |

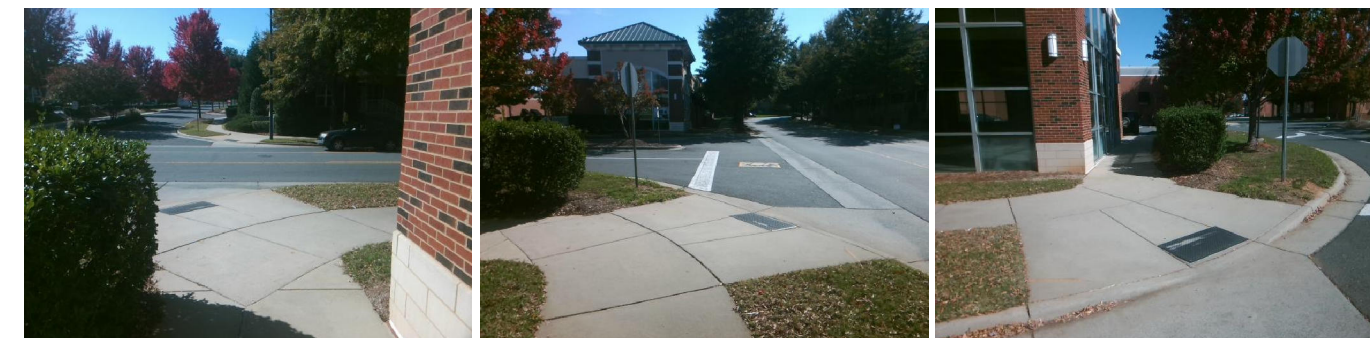
| ADA ID: 7BA80AC224E7 | Ramp Type: PerpDiag | Initial Pass/Fail: Fail | Overall Compliance: No |

| Compliance | Description | Data | Compliance | Description | Data |
|---|---|---|---|---|---|
| No | Ramp Width (in) | 30.0 | Yes | Ramp XSlope (%) | 1.2 |

Remove & Replace Curb Ramp With Two New Directional Ramps or Equivalent.
