# Access Compliance Report

## Public Rights-of-Way

### (Curb Ramps)

| Intersection ID: 44158 | Main Street: MEADOW_KNOLL_DR | Cross Street: FEATHER_BEND_CT | Location: SW |

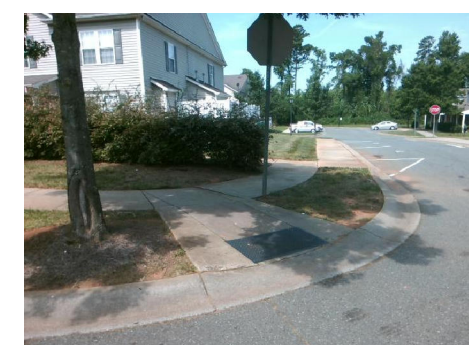
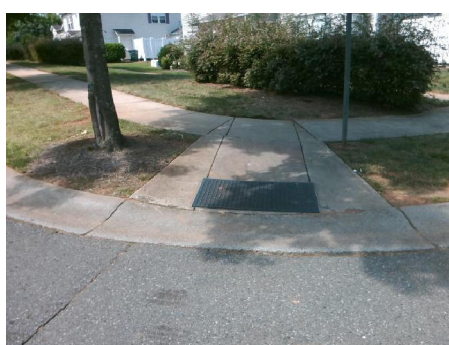
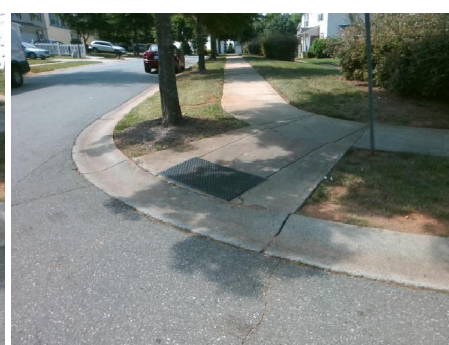
**Not Found, R304.5.1, R304.2.2, R304.5.3**

| Compliance | Description | Data | Compliance | Description | Data |
|---|---|---|---|---|---|
| N/A | Ramp Length (in) | 87.5 | No | Ramp Slope (%) | 10.7 |
| No | Ramp Width (in) | 44.0 | No | Ramp XSlope (%) | 3.6 |

**Remove & Replace Curb Ramp With Two New Directional Ramps or Equivalent.**
