Access Compliance Report

Public Rights-of-Way

(Curb Ramps)

| Intersection ID: 3806 | Main Street: BRIARCREST_CT | Cross Street: CHESTNUT_KNOLL_LN | Location: E |

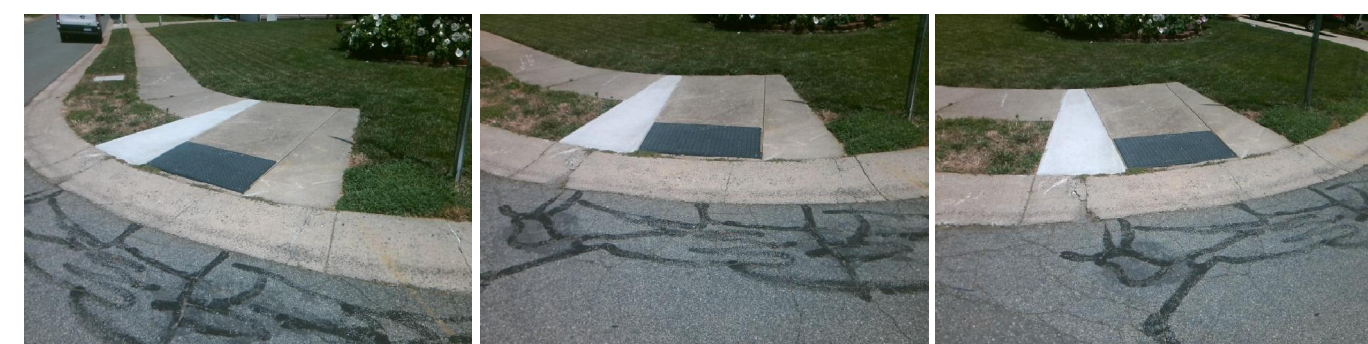
Not Found, R304.5.1, R304.5.3

| Compliance | Description | Data | Compliance | Description | Data |
|---|---|---|---|---|---|
| No | Ramp Width (in) | 46.0 | No | Ramp XSlope (%) | 6.9 |

Remove & Replace Entire Ramp.
