# Access Compliance Report

## Public Rights-of-Way

### (Curb Ramps)

| Intersection ID: 11389 | Main Street: E_18TH_ST | Cross Street: N_CALDWELL_ST | Location: N |

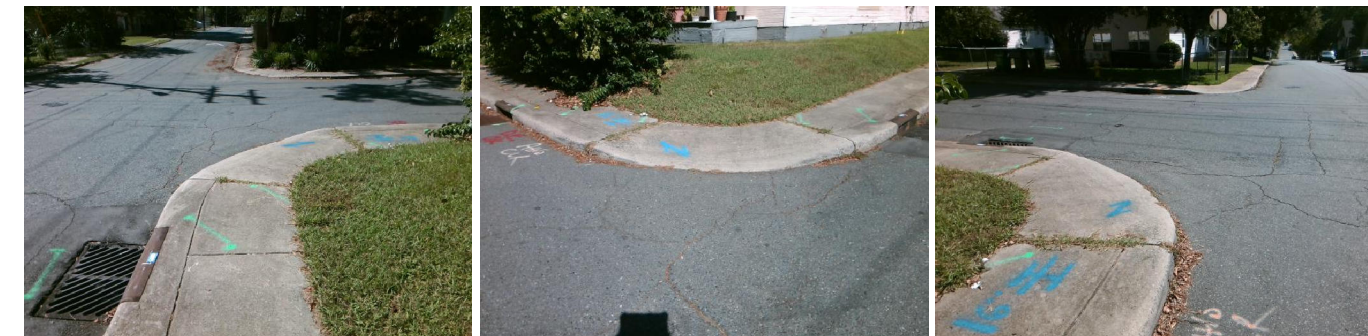
**Not Found, R304.5.1, R304.2.2, R304.5.3**

| Compliance | Description | Data | Compliance | Description | Data |
|---|---|---|---|---|---|
| N/A | Ramp Length (in) | 55.0 | No | Ramp Slope (%) | 14.5 |
| No | Ramp Width (in) | 46.0 | No | Ramp XSlope (%) | 6.4 |

**Remove & Replace Curb Ramp With Two New Directional Ramps or Equivalent.**
