Access Compliance Report

Public Rights-of-Way

(Curb Ramps)

Intersection ID: 9818	Main Street: EDGEWOOD_RD	Cross Street: LOCH_LEVEN_ST	Location: S
ADA ID: 7F926BD30B29	Ramp Type: Perp	Initial Pass/Fail: Fail	Overall Compliance: No
Severity Score: 36.25			
Codes/Mitigation Info/Possible Solution		Field Measurements/Component Compliance

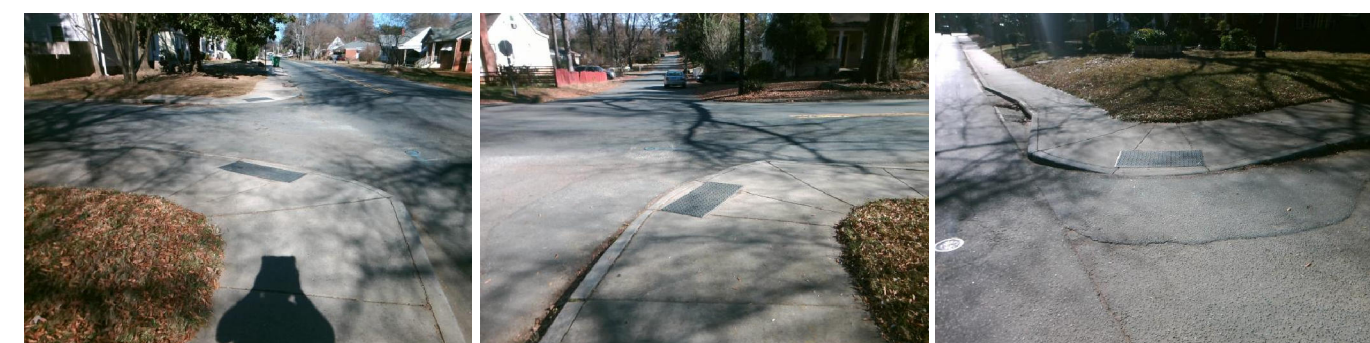
Not Found, R304.5.1, R304.5.3

Compliance	Description	Data	Compliance	Description	Data
N/A	Ramp Length (in)	87.0	Yes	Ramp Slope (%)	7.5
No	Ramp Width (in)	24.0	No	Ramp XSlope (%)	3.9
N/A	Flare Type LT	N/A	N/A	Flare Type RT	N/A
N/A	Flare Slope LT (%)	N/A	N/A	Flare Slope RT (%)	N/A
N/A	Flare Traversable LT?	N/A	N/A	Flare Traversable RT?	N/A
N/A	Landing Length (in)	N/A	N/A	DWS Provided?	N/A
N/A	Landing Width (in)	N/A	N/A	DWS Contrast?	N/A
N/A	Landing Slope (%)	N/A	N/A	DWS Length (in)	N/A
N/A	Landing X Slope (%)	N/A	N/A	DWS Full Width?	N/A
N/A	Landing Curb? (Y/N)	N/A	N/A	DWS Offset (in)	N/A
N/A	Shared Landing?	N/A			
N/A	Gutter Ponding?	N/A	N/A	Gutter Slope (%)	N/A
N/A	Gutter Lip Ht (in)	N/A	N/A	Gutter X Slope (%)	N/A
N/A	Painted X Walk1?	No	N/A	Painted X Walk2?	N/A
	X Walk 1 Direction	To N		X Walk 2 Direction	N/A
N/A	X Walk 1 Width (in)	N/A	N/A	X Walk 2 Width (in)	N/A
	X Walk 1 Slope (%)	1.4		X Walk 2 Slope (%)	N/A
	X Walk 1 X Slope (%)	3.5		X Walk 2 X Slope (%)	N/A

N/A	Ramp inside XWalk1?	N/A	N/A	Ramp inside XWalk2?	N/A
	Road Slope (%)	N/A	N/A	Clear Space?	N/A
	Road X Slope (%)	N/A	N/A	Clear Space to XWalk (in)	N/A
N/A	Any Obstructions?	N/A	N/A	Storm Grate/Utility Hazard?	N/A
	Obstruction Type			Storm Grate/Utility Type	
		N/A			N/A
		Yes		Surface Condition? (G/P)	Good

Remove & Replace Entire Ramp.
