# Access Compliance Report

## Public Rights-of-Way

### (Curb Ramps)

Intersection ID: 50608	Main Street: DENBUR_DR	Cross Street: DOWNY_BIRCH_RD	Location: NE
ADA ID: 805FC987027D	Ramp Type: Perp	Initial Pass/Fail: Pass	Overall Compliance: No
Severity Score: 10.25			
Codes/Mitigation Info/Possible Solution		Field Measurements/Component Compliance

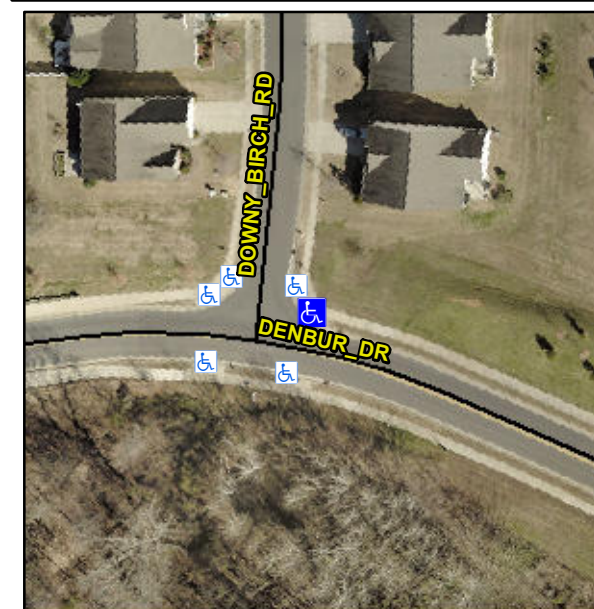
**Not Found, R304.5.3, R304.2.1, R304.2.2-Perp, R304.3.2-Para**

Compliance	Description	Data	Compliance	Description	Data
N/A	Ramp Length (in)	106.0	Yes	Ramp Slope (%)	7.3
Yes	Ramp Width (in)	48.0	No	Ramp XSlope (%)	2.4
N/A	Flare Type LT	Sloped	N/A	Flare Type RT	N/A
N/A	Flare Slope LT (%)	3.7	N/A	Flare Slope RT (%)	9.6
N/A	Flare Traversable LT?	No	N/A	Flare Traversable RT?	No
No	Landing Length (in)	N/A	Yes	DWS Provided?	Yes
No	Landing Width (in)	N/A	Yes	DWS Contrast?	Yes
No	Landing Slope (%)	N/A	Yes	DWS Length (in)	24.5
No	Landing X Slope (%)	N/A	Yes	DWS Full Width?	Yes
N/A	Landing Curb? (Y/N)	No	Yes	DWS Offset (in)	1.0
N/A	Shared Landing?	No			
Yes	Gutter Ponding?	No	Yes	Gutter Slope (%)	4.4
Yes	Gutter Lip Ht (in)	0.0	Yes	Gutter X Slope (%)	1.9
N/A	Painted X Walk1?	No	N/A	Painted X Walk2?	N/A
	X Walk 1 Direction	To S		X Walk 2 Direction	N/A
N/A	X Walk 1 Width (in)	N/A	N/A	X Walk 2 Width (in)	N/A
	X Walk 1 Slope (%)	1.8		X Walk 2 Slope (%)	N/A
	X Walk 1 X Slope (%)	1.6		X Walk 2 X Slope (%)	N/A

N/A	Ramp inside XWalk1?	N/A	N/A	Ramp inside XWalk2?	N/A
	Road Slope (%)	N/A	N/A	Clear Space?	Yes
	Road X Slope (%)	N/A	N/A	Clear Space to XWalk (in)	N/A
Yes	Any Obstructions?	No	Yes	Storm Grate/Utility Hazard?	No
	Obstruction Type			Storm Grate/Utility Type	
			N/A		N/A
			Yes	Surface Condition? (G/P)	Good

**Remove & Replace Entire Ramp.**
