Access Compliance Report

Public Rights-of-Way

(Curb Ramps)

| Intersection ID: 6882 | Main Street: STATESVILLE_RD | Cross Street: CINDY_LN | Location: NW |

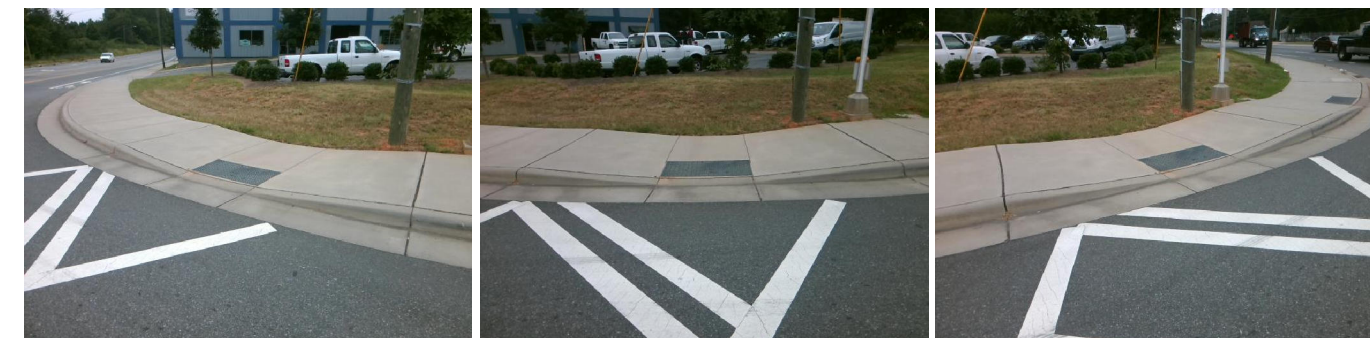
| Compliance | Description | Data | Compliance | Description | Data |
|---|---|---|---|---|---|
| Yes | Ramp Slope LT (%) | 6.2 | No | Ramp Slope RT (%) | 8.9 |

Remove & Replace Entire Ramp.
