# Access Compliance Report

## Public Rights-of-Way

Intersection ID: 50321	Main Street: BELMAR_PLACE_RD	Cross Street: CINDY_LN	Location: SW
ADA ID: 82809CB4D27B	Ramp Type: Directional1	Initial Pass/Fail: Fail	Overall Compliance: No
		Severity Score: 12.5

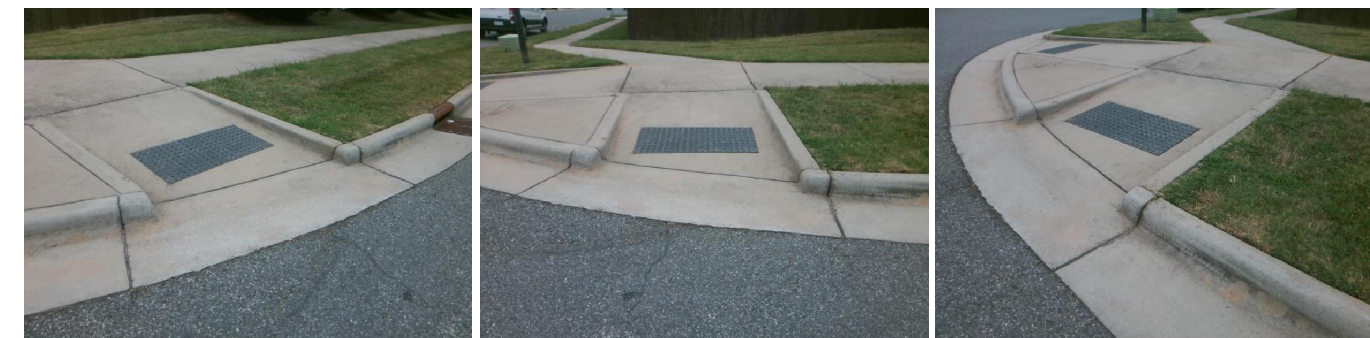
Compliance	Description	Data	Compliance	Description	Data
N/A	Ramp Length (in)	76.0	N/A	Grade Break?	N/A
Yes	Ramp Width (in)	67.5	N/A	Grade Break Slope (%)	0.0
Yes	Ramp Slope (%)	7.9	N/A	Grade Break XSlope (%)	0.0
No	Ramp XSlope (%)	5.8			
N/A	Flare Type LT	N/A	N/A	Flare Type RT	N/A
N/A	Flare Slope LT (%)	N/A	N/A	Flare Slope RT (%)	0.0
N/A	Flare Traversable LT?	N/A	N/A	Flare Traversable RT?	N/A
N/A	Landing Length (in)	0.0	N/A	DWS Provided?	N/A
N/A	Landing Width (in)	0.0	N/A	DWS Contrast?	N/A
N/A	Landing Slope (%)	0.0	N/A	DWS Length (in)	N/A
N/A	Landing X Slope (%)	0.0	N/A	DWS Full Width?	N/A
N/A	Landing Curb? (Y/N)	N/A	N/A	DWS Offset LT (in)	N/A
N/A	Shared Landing?	N/A	N/A	DWS Offset RT (in)	N/A
N/A	Gutter Ponding?	0.0	N/A	Gutter Slope (%)	N/A
N/A	Gutter Lip Ht (in)	0.0	N/A	Gutter X Slope (%)	N/A
N/A	Painted X Walk1?	No		Road Slope (%)	1.1
	X Walk 1 Direction	To N		Road X Slope (%)	4.8
	X Walk 1 Width (in)	N/A		Clear Space?	N/A

X Walk 1 Slope (%)	1.1	N/A	Clear Space to XWalk (in)	N/A
	X Walk 1 X Slope (%)	4.8	N/A	Storm Grate/Utility Hazard?	N/A
N/A	Ramp inside XWalk1?	N/A		Storm Grate/Utility Type	
N/A	Any Obstructions?	N/A			N/A
	Obstruction Type		Yes	Surface Condition? (G/P)	Good
			N/A	Curb Slope (%)	N/A

**Remove & Replace Entire Ramp.**
