# Access Compliance Report

## Public Rights-of-Way

### (Curb Ramps)

Intersection ID: 48304	Main Street: FAZENDA_DR	Cross Street: GANSO_LN	Location:	E
ADA ID: 83637381543D	Ramp Type: PerpDiag	Initial Pass/Fail: Fail	Overall Compliance: No	Severity Score: 25

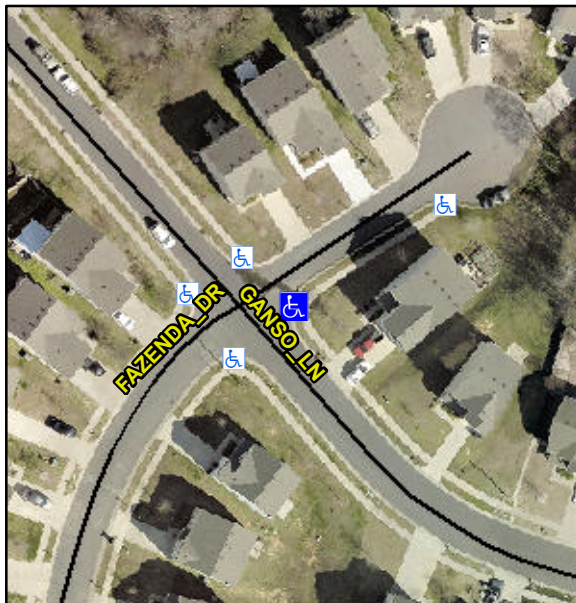
**Not Found, R304.2.2, R304.5.3**

Compliance	Description	Data	Compliance	Description	Data
N/A	Ramp Length (in)	49.0	No	Ramp Slope (%)	10.5
Yes	Ramp Width (in)	48.0	No	Ramp XSlope (%)	6.8
N/A	Flare Type LT	N/A	N/A	Flare Type RT	N/A
N/A	Flare Slope LT (%)	N/A	N/A	Flare Slope RT (%)	N/A
N/A	Flare Traversable LT?	N/A	N/A	Flare Traversable RT?	N/A
N/A	Landing Length (in)	N/A	N/A	DWS Provided?	N/A
N/A	Landing Width (in)	N/A	N/A	DWS Contrast?	N/A
N/A	Landing Slope (%)	N/A	N/A	DWS Length (in)	N/A
N/A	Landing X Slope (%)	N/A	N/A	DWS Full Width?	N/A
N/A	Landing Curb? (Y/N)	N/A	N/A	DWS Offset (in)	N/A
N/A	Shared Landing?	N/A			
N/A	Gutter Ponding?	N/A	N/A	Gutter Slope (%)	N/A
N/A	Gutter Lip Ht (in)	N/A	N/A	Gutter X Slope (%)	N/A
N/A	Painted X Walk1?	No	N/A	Painted X Walk2?	No
	X Walk 1 Direction	To NW		X Walk 2 Direction	To SW
N/A	X Walk 1 Width (in)	N/A	N/A	X Walk 2 Width (in)	N/A
	X Walk 1 Slope (%)	1.4		X Walk 2 Slope (%)	4.2
	X Walk 1 X Slope (%)	3.5		X Walk 2 X Slope (%)	6.3

N/A	Ramp inside XWalk1?	N/A	N/A	Ramp inside XWalk2?	N/A
	Road Slope (%)	4.5	N/A	Clear Space?	N/A
	Road X Slope (%)	1.9	N/A	Clear Space to XWalk (in)	N/A
N/A	Any Obstructions?	N/A	N/A	Storm Grate/Utility Hazard?	N/A
	Obstruction Type			Storm Grate/Utility Type	
		N/A			N/A
			Yes	Surface Condition? (G/P)	Good

**Remove & Replace Curb Ramp With Two New Directional Ramps or Equivalent.**
