Access Compliance Report

Public Rights-of-Way (Curb Ramps)

| Intersection ID: 10025574 | Main Street: E_W_T_HARRIS_BV | Cross Street: N/A | Location: NW |
| ADA ID: 83C077ED8E9A | Ramp Type: Combination1 | Initial Pass/Fail: Fail | Overall Compliance: No |

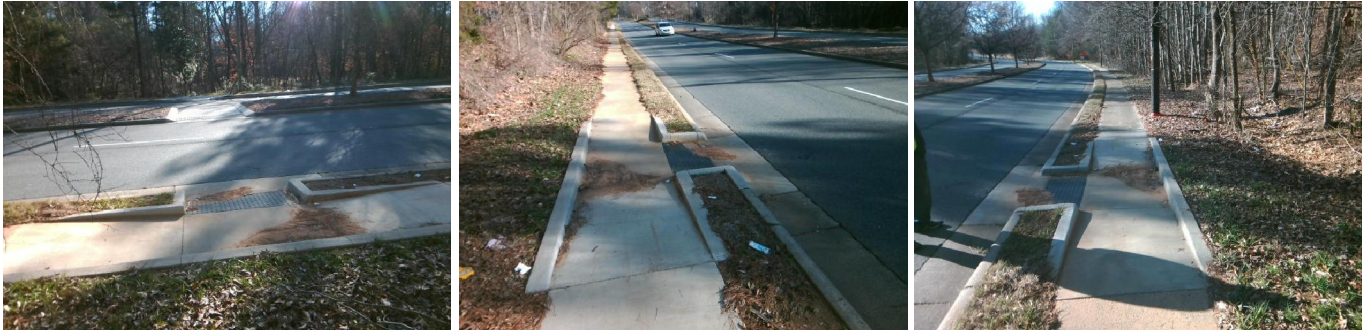
| Codes/Mitigation Info/Possible Solution | | | Field Measurements/Component Compliance | | |
|---|---|--|---|---|---|
| | Remove & Replace Sidewalk. | | No | Ramp Width LT (in) | 47.0 |
| <p>PROW/ADA:</p> <p>Not Found, R304.5.1</p> | | | N/A | Landing Length (in) | N/A |

| Codes/Mitigation Info/Possible Solution | | | Field Measurements/Component Compliance | | |
|---|---|--|---|---|---|
| | Remove & Replace Entire Ramp. | | N/A | Ramp Length LT (in) | 75.0 |
