# Access Compliance Report

## Public Rights-of-Way

### (Curb Ramps)

Intersection ID: 52127	Main Street: VALLEYDALE_RD	Cross Street: FRED_D_ALEXANDER_BV	Location: W
ADA ID: 84205FAA6785	Ramp Type: Combination1	Initial Pass/Fail: Fail	Overall Compliance: No
Severity Score: 13.75			
Codes/Mitigation Info/Possible Solution		Field Measurements/Component Compliance

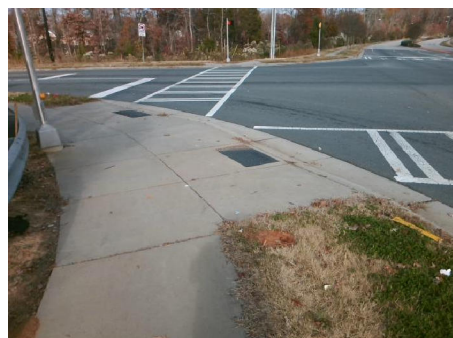
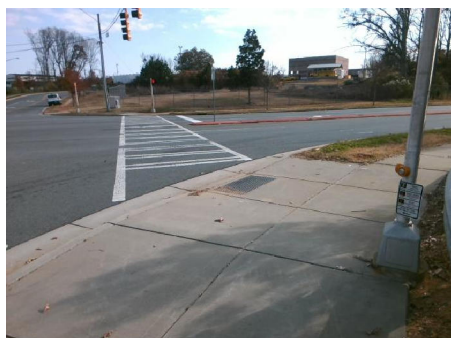
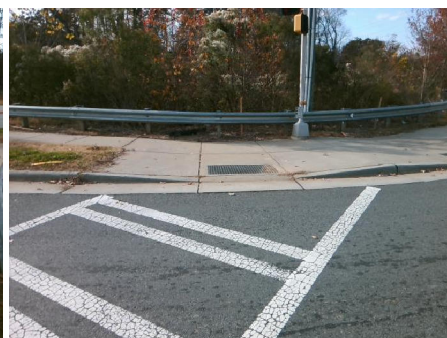
**RP & RT RP < 5%**

**Not Found, R304.5.3, R304.3.2**

Compliance	Description	Data	Compliance	Description	Data
N/A	Ramp Length LT (in)	61.0	N/A	Ramp Length RT (in)	59.0
Yes	Ramp Width LT (in)	60.0	Yes	Ramp Width RT (in)	60.0
No	Ramp Slope LT (%)	8.6	Yes	Ramp Slope RT (%)	2.1
Yes	Ramp XSlope LT (%)	0.5	Yes	Ramp XSlope RT (%)	0.4
N/A	Ramp Length (in)	68.0	Yes	Ramp Slope (%)	2.2
Yes	Ramp Width (in)	56.0	No	Ramp XSlope (%)	3.2
N/A	Flare Type LT	N/A	N/A	Flare Type RT	N/A
N/A	Flare Slope LT (%)	N/A	N/A	Flare Slope RT (%)	N/A
N/A	Flare Traversable LT?	N/A	N/A	Flare Traversable RT?	N/A
N/A	Landing Length (in)	N/A	N/A	DWS Provided?	N/A
N/A	Landing Width (in)	N/A	N/A	DWS Contrast?	N/A
N/A	Landing Slope (%)	N/A	N/A	DWS Length (in)	N/A
N/A	Landing X Slope (%)	N/A	N/A	DWS Full Width?	N/A
N/A	Landing Curb? (Y/N)	N/A	N/A	DWS Offset (in)	N/A
N/A	Shared Landing?	N/A			
N/A	Gutter Ponding?	N/A	N/A	Gutter Slope (%)	N/A
N/A	Gutter Lip Ht (in)	0.5	N/A	Gutter X Slope (%)	N/A
N/A	Painted X Walk1?	Yes	N/A	Painted X Walk2?	N/A

**Remove & Replace Entire Ramp.**
