Access Compliance Report

Public Rights-of-Way

(Curb Ramps)

Intersection ID: 11450	Main Street: GRANDIN_RD	Cross Street: W MARTIN LUTHER KING JR BV	Location: N
ADA ID: 846A338D9D78	Ramp Type: Perp	Initial Pass/Fail: Fail	Overall Compliance: No
			Severity Score: 10

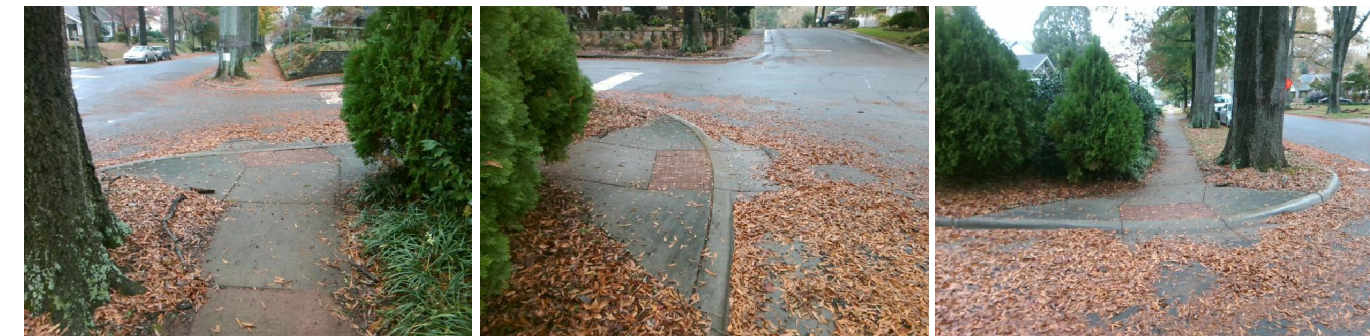
Not Found, R304.5.1, R304.5.3

Compliance	Description	Data	Compliance	Description	Data
N/A	Ramp Length (in)	77.0	Yes	Ramp Slope (%)	7.9
No	Ramp Width (in)	44.0	No	Ramp XSlope (%)	2.6
N/A	Flare Type LT	N/A	N/A	Flare Type RT	N/A
N/A	Flare Slope LT (%)	N/A	N/A	Flare Slope RT (%)	N/A
N/A	Flare Traversable LT?	N/A	N/A	Flare Traversable RT?	N/A
N/A	Landing Length (in)	N/A	N/A	DWS Provided?	N/A
N/A	Landing Width (in)	N/A	N/A	DWS Contrast?	N/A
N/A	Landing Slope (%)	N/A	N/A	DWS Length (in)	N/A
N/A	Landing X Slope (%)	N/A	N/A	DWS Full Width?	N/A
N/A	Landing Curb? (Y/N)	N/A	N/A	DWS Offset (in)	N/A
N/A	Shared Landing?	N/A			
N/A	Gutter Ponding?	N/A	N/A	Gutter Slope (%)	N/A
N/A	Gutter Lip Ht (in)	N/A	N/A	Gutter X Slope (%)	N/A
N/A	Painted X Walk1?	No	N/A	Painted X Walk2?	N/A
	X Walk 1 Direction	To S		X Walk 2 Direction	N/A
N/A	X Walk 1 Width (in)	N/A	N/A	X Walk 2 Width (in)	N/A
	X Walk 1 Slope (%)	3.0		X Walk 2 Slope (%)	N/A
	X Walk 1 X Slope (%)	2.4		X Walk 2 X Slope (%)	N/A

N/A	Ramp inside XWalk1?	N/A	N/A	Ramp inside XWalk2?	N/A
	Road Slope (%)	N/A	N/A	Clear Space?	N/A
	Road X Slope (%)	N/A	N/A	Clear Space to XWalk (in)	N/A
N/A	Any Obstructions?	N/A	N/A	Storm Grate/Utility Hazard?	N/A
	Obstruction Type			Storm Grate/Utility Type	
		N/A			N/A
			Yes	Surface Condition? (G/P)	Good

Remove & Replace Entire Ramp.
