Access Compliance Report

Public Rights-of-Way

(Curb Ramps)

| Intersection ID: 52289 | Main Street: TROJAN_DR | Cross Street: DIXIE_RIVER_RD | Location: N |

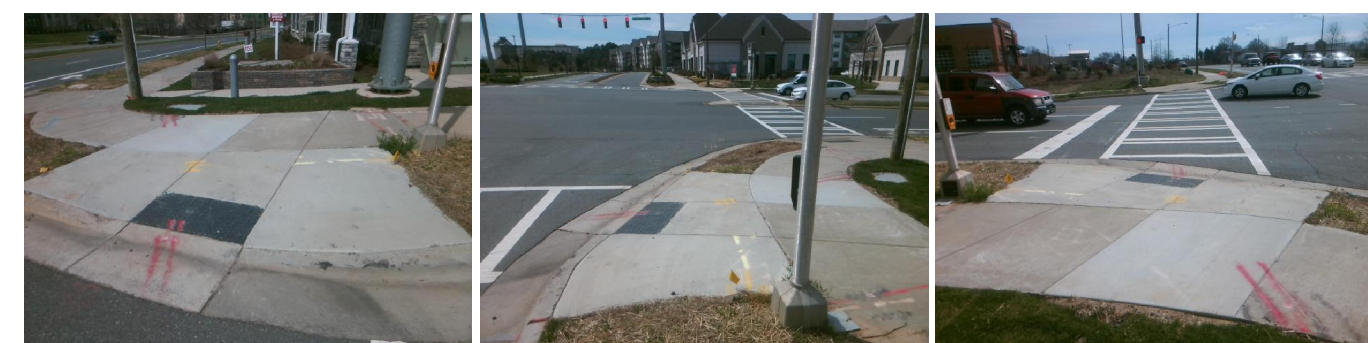
| ADA ID: 8631DB54AB0F | Ramp Type: Perp | Initial Pass/Fail: Fail | Overall Compliance: No |

Not Found, R304.2.2, R304.5.3

| Compliance | Description | Data | Compliance | Description | Data |
|---|---|---|---|---|---|
| N/A | Ramp Length (in) | 68.0 | No | Ramp Slope (%) | 12.3 |
| Yes | Ramp Width (in) | 48.0 | No | Ramp XSlope (%) | 3.2 |

Remove & Replace Entire Ramp.
