Access Compliance Report

Public Rights-of-Way

(Curb Ramps)

| Intersection ID: 12310 | Main Street: WEYLAND_AV | Cross Street: GREENLAND_AV | Location: NW |

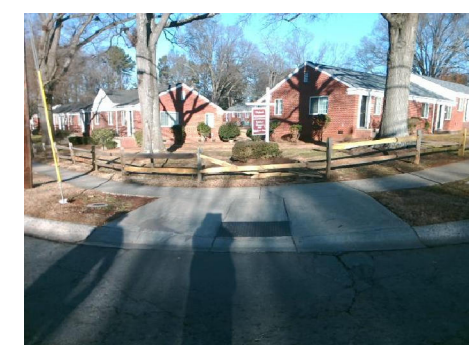
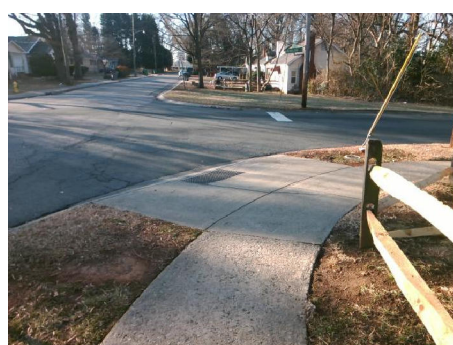
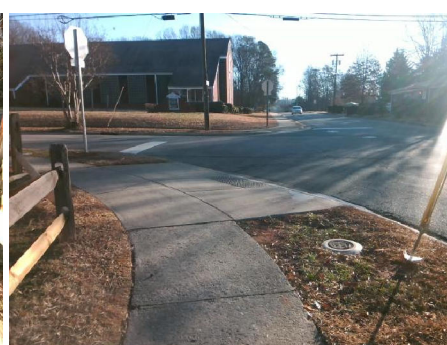
Not Found, R304.5.1, R304.2.2, R304.5.3

| Compliance | Description | Data | Compliance | Description | Data |
|---|---|---|---|---|---|
| N/A | Ramp Length (in) | 78.0 | No | Ramp Slope (%) | 8.8 |
| No | Ramp Width (in) | 39.0 | No | Ramp XSlope (%) | 5.2 |

Remove & Replace Entire Ramp.
