# Access Compliance Report

## Public Rights-of-Way

### (Curb Ramps)

| Intersection ID: 10025796 | Main Street: EDGEHILL_RD_NORTH | Cross Street: N/A | Location: SE |

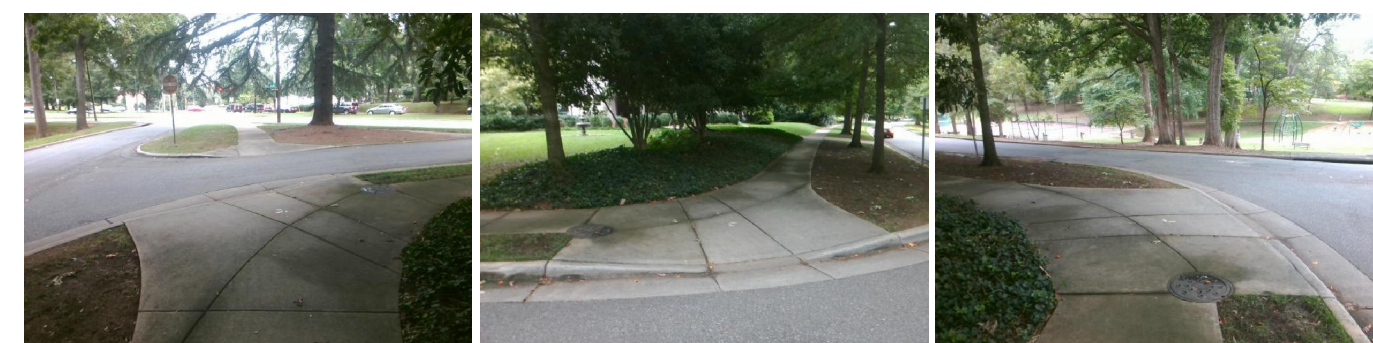
| ADA ID: 87DA79D090F8 | Ramp Type: PerpDiag | Initial Pass/Fail: Fail | Overall Compliance: No |

| | Remove & Replace Curb Ramp With Two New Directional Ramps or Equivalent. | N/A | Ramp Length (in) | 63.0 | No | Ramp Slope (%) | 10.8 |
| | | No | Ramp Width (in) | 37.0 | Yes | Ramp XSlope (%) | 4.5 |
| <p>Surveyor Notes:</p> <p>N/A</p> <p>PROW/ADA:</p> <p>Not Found, R304.5.1, R304.2.2</p> | | | Road Slope (%) | 4.5 | N/A | Clear Space? | N/A |
