Access Compliance Report

Public Rights-of-Way

| Intersection ID: 45635 | Main Street: KELSEY_EMMA_CT | Cross Street: MOLLY_ELIZABETH_LN | Location: NW |
| ADA ID: 88056CA3DB2F | Ramp Type: Perp | Initial Pass/Fail: Pass | Overall Compliance: No |

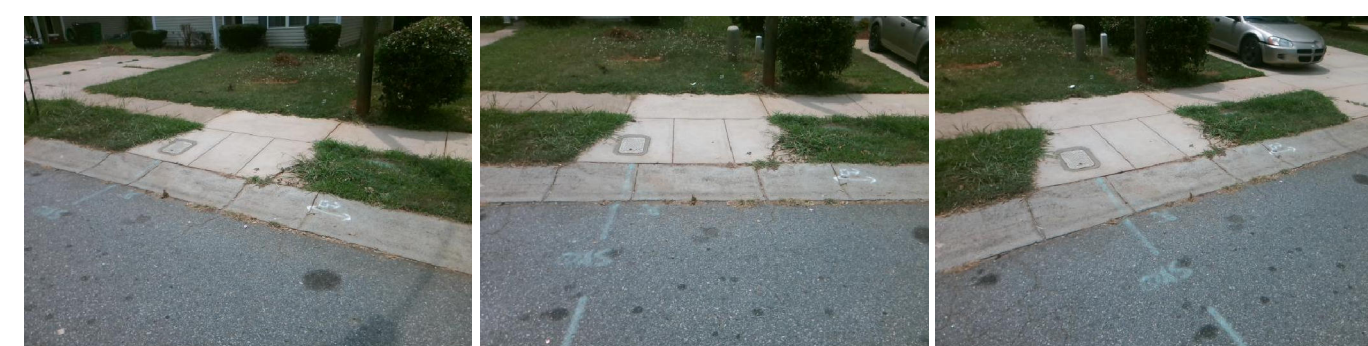
| | | | Severity Score: 15.25 |

| Compliance | Description | Data | Compliance | Description | Data |
|---|---|---|---|---|---|
| Yes | Landing Length (in) | 48.0 | No | DWS Provided? | No |

| Codes/Mitigation Info/Possible Solution | | Field Measurements/Component Compliance | | | |
|--|---|---|---|--|--|
| | Remove & Replace Entire Ramp. | | | | |
| | Remove & Replace Gutter. | | | | |
