# Access Compliance Report

## Public Rights-of-Way

### (Curb Ramps)

| Intersection ID: 10862 | Main Street: N_GRAHAM_ST | Cross Street: DALTON_AV | Location: SE |

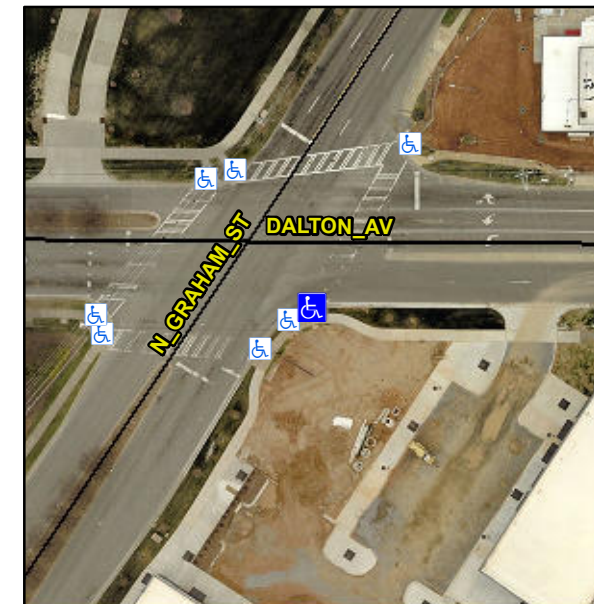
**RT RP < 5%**

**Not Found, R304.5.3, R304.2.1,  
R304.2.2-Perp, R304.3.2-Para,  
R305.1.4, R305.2**

| Compliance | Description | Data | Compliance | Description | Data |
|---|---|---|---|---|---|
| No | Ramp XSlope LT (%) | 3.2 | No | Ramp XSlope RT (%) | 3.2 |

**Remove & Replace Entire Ramp.  
Remove & Replace Sidewalk.**
