Access Compliance Report

Public Rights-of-Way

(Curb Ramps)

Intersection ID: 50321	Main Street: BELMAR_PLACE_RD	Cross Street: CINDY_LN	Location: NW
ADA ID: 891D91EB5680	Ramp Type: Directional1	Initial Pass/Fail: Fail	Overall Compliance: No
		Severity Score: 25

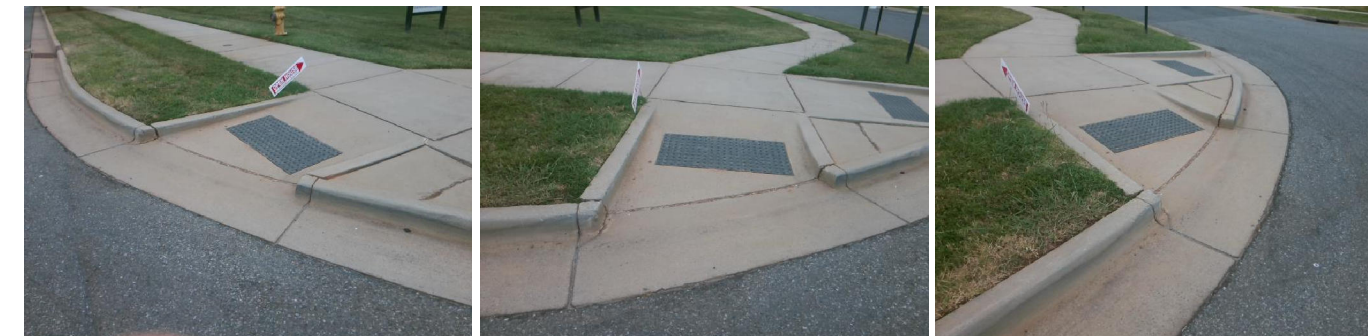
R304.2.2, R304.5.3

Compliance	Description	Data	Compliance	Description	Data
N/A	Ramp Length (in)	59.0	N/A	Grade Break?	N/A
Yes	Ramp Width (in)	63.0	N/A	Grade Break Slope (%)	0.0
No	Ramp Slope (%)	8.9	N/A	Grade Break XSlope (%)	0.0
No	Ramp XSlope (%)	6.7			
N/A	Flare Type LT	N/A	N/A	Flare Type RT	N/A
N/A	Flare Slope LT (%)	N/A	N/A	Flare Slope RT (%)	0.0
N/A	Flare Traversable LT?	N/A	N/A	Flare Traversable RT?	N/A
N/A	Landing Length (in)	0.0	N/A	DWS Provided?	N/A
N/A	Landing Width (in)	0.0	N/A	DWS Contrast?	N/A
N/A	Landing Slope (%)	0.0	N/A	DWS Length (in)	N/A
N/A	Landing X Slope (%)	0.0	N/A	DWS Full Width?	N/A
N/A	Landing Curb? (Y/N)	N/A	N/A	DWS Offset LT (in)	N/A
N/A	Shared Landing?	N/A	N/A	DWS Offset RT (in)	N/A
N/A	Gutter Ponding?	0.0	N/A	Gutter Slope (%)	N/A
N/A	Gutter Lip Ht (in)	0.0	N/A	Gutter X Slope (%)	N/A
N/A	Painted X Walk1?	No		Road Slope (%)	4.4
	X Walk 1 Direction	To S		Road X Slope (%)	2.3
	X Walk 1 Width (in)	N/A		Clear Space?	N/A

Remove & Replace Entire Ramp.
