Access Compliance Report

Public Rights-of-Way

(Curb Ramps)

Intersection ID: 49397	Main Street: HERFORD_ST	Cross Street: DAMASCUS_ST	Location: SE
ADA ID: 8AE8D2DA8D51	Ramp Type: PerpDiag	Initial Pass/Fail: Fail	Overall Compliance: No
		Severity Score: 21.25

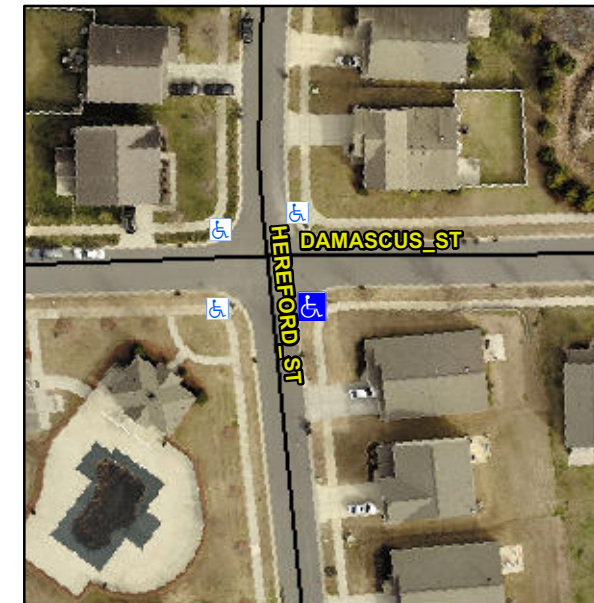
Not Found, R304.5.1, R304.5.3

Compliance	Description	Data	Compliance	Description	Data
N/A	Ramp Length (in)	73.5	Yes	Ramp Slope (%)	6.2
No	Ramp Width (in)	47.0	No	Ramp XSlope (%)	6.3
N/A	Flare Type LT	N/A	N/A	Flare Type RT	N/A
N/A	Flare Slope LT (%)	N/A	N/A	Flare Slope RT (%)	N/A
N/A	Flare Traversable LT?	N/A	N/A	Flare Traversable RT?	N/A
N/A	Landing Length (in)	N/A	N/A	DWS Provided?	N/A
N/A	Landing Width (in)	N/A	N/A	DWS Contrast?	N/A
N/A	Landing Slope (%)	N/A	N/A	DWS Length (in)	N/A
N/A	Landing X Slope (%)	N/A	N/A	DWS Full Width?	N/A
N/A	Landing Curb? (Y/N)	N/A	N/A	DWS Offset (in)	N/A
N/A	Shared Landing?	N/A			
N/A	Gutter Ponding?	N/A	N/A	Gutter Slope (%)	N/A
N/A	Gutter Lip Ht (in)	N/A	N/A	Gutter X Slope (%)	N/A
N/A	Painted X Walk1?	No	N/A	Painted X Walk2?	No
	X Walk 1 Direction	To N		X Walk 2 Direction	To W
N/A	X Walk 1 Width (in)	N/A	N/A	X Walk 2 Width (in)	N/A
	X Walk 1 Slope (%)	1.8		X Walk 2 Slope (%)	1.8
	X Walk 1 X Slope (%)	0.2		X Walk 2 X Slope (%)	2.1

N/A	Ramp inside XWalk1?	N/A	N/A	Ramp inside XWalk2?	N/A
	Road Slope (%)	3.1	N/A	Clear Space?	N/A
	Road X Slope (%)	1.4	N/A	Clear Space to XWalk (in)	N/A
N/A	Any Obstructions?	N/A	N/A	Storm Grate/Utility Hazard?	N/A
	Obstruction Type			Storm Grate/Utility Type	
		N/A			N/A
			Yes	Surface Condition? (G/P)	Good

Remove & Replace Curb Ramp With Two New Directional Ramps or Equivalent.
