# Access Compliance Report

## Public Rights-of-Way

### (Curb Ramps)

Intersection ID: 50606	Main Street: DENBUR_DR	Cross Street: BENDING_BRANCH_RD	Location: S
ADA ID: 8B0DBEDE08DB	Ramp Type: Perp	Initial Pass/Fail: Fail	Overall Compliance: No
Severity Score: 13.75			
Codes/Mitigation Info/Possible Solution		Field Measurements/Component Compliance

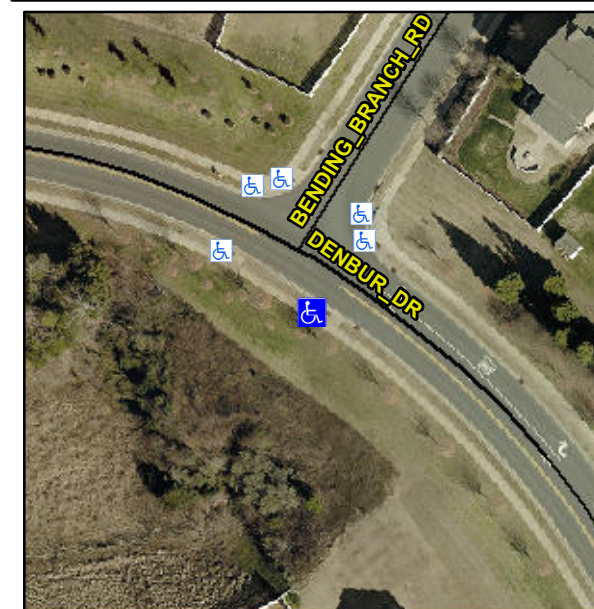
**Not Found, R304.2.2**

Compliance	Description	Data	Compliance	Description	Data
N/A	Ramp Length (in)	49.5	No	Ramp Slope (%)	11.5
Yes	Ramp Width (in)	48.0	Yes	Ramp XSlope (%)	3.7
N/A	Flare Type LT	N/A	N/A	Flare Type RT	N/A
N/A	Flare Slope LT (%)	N/A	N/A	Flare Slope RT (%)	N/A
N/A	Flare Traversable LT?	N/A	N/A	Flare Traversable RT?	N/A
N/A	Landing Length (in)	N/A	N/A	DWS Provided?	N/A
N/A	Landing Width (in)	N/A	N/A	DWS Contrast?	N/A
N/A	Landing Slope (%)	N/A	N/A	DWS Length (in)	N/A
N/A	Landing X Slope (%)	N/A	N/A	DWS Full Width?	N/A
N/A	Landing Curb? (Y/N)	N/A	N/A	DWS Offset (in)	N/A
N/A	Shared Landing?	N/A			
N/A	Gutter Ponding?	N/A	N/A	Gutter Slope (%)	N/A
N/A	Gutter Lip Ht (in)	N/A	N/A	Gutter X Slope (%)	N/A
N/A	Painted X Walk1?	No	N/A	Painted X Walk2?	N/A
	X Walk 1 Direction	To NE		X Walk 2 Direction	N/A
N/A	X Walk 1 Width (in)	N/A	N/A	X Walk 2 Width (in)	N/A
	X Walk 1 Slope (%)	2.2		X Walk 2 Slope (%)	N/A
	X Walk 1 X Slope (%)	4.4		X Walk 2 X Slope (%)	N/A

**Remove & Replace Entire Ramp.**
