Access Compliance Report

Public Rights-of-Way

(Curb Ramps)

Intersection ID: 9251	Main Street: MORETZ_AV	Cross Street: OLANDO_ST	Location: S
ADA ID: 8BB4BFFFC9E3	Ramp Type: Para	Initial Pass/Fail: Fail	Overall Compliance: No
Severity Score: 37.5			
Codes/Mitigation Info/Possible Solution		Field Measurements/Component Compliance

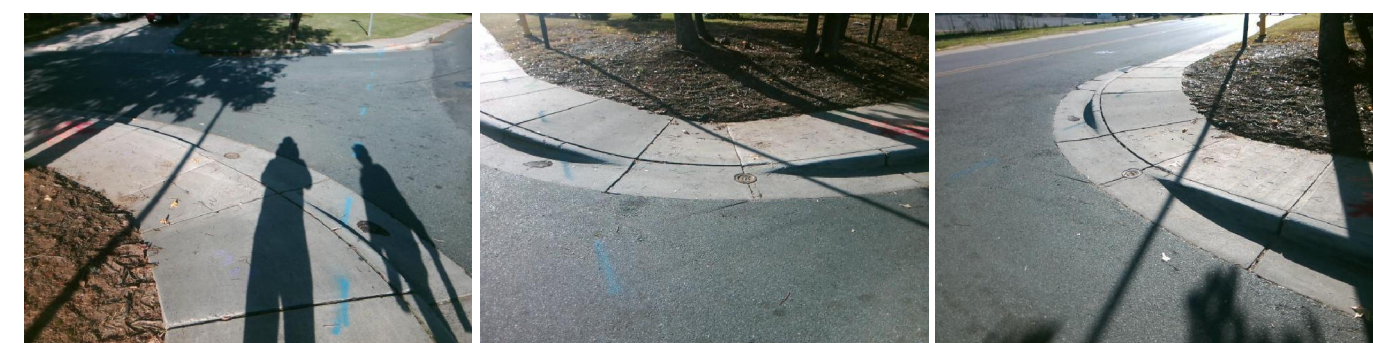
DWS NAILS EXPOSED, RT RP < 5%

Compliance	Description	Data	Compliance	Description	Data
N/A	Ramp Length LT (in)	49.0	N/A	Ramp Length RT (in)	53.0
Yes	Ramp Width LT (in)	59.5	Yes	Ramp Width RT (in)	62.0
No	Ramp Slope LT (%)	16.0	Yes	Ramp Slope RT (%)	2.6
No	Ramp XSlope LT (%)	5.2	No	Ramp XSlope RT (%)	2.6
N/A	Landing Length (in)	N/A	N/A	DWS Provided?	N/A
N/A	Landing Width (in)	N/A	N/A	DWS Contrast?	N/A
N/A	Landing Slope (%)	N/A	N/A	DWS Length (in)	N/A
N/A	Landing X Slope (%)	N/A	N/A	DWS Full Width?	N/A
N/A	Landing Curb? (Y/N)	N/A	N/A	DWS Offset (in)	N/A
N/A	Shared Landing?	N/A			
N/A	Gutter Ponding?	N/A	N/A	Gutter Slope (%)	N/A
N/A	Gutter Lip Ht (in)	N/A	N/A	Gutter X Slope (%)	N/A
N/A	Painted X Walk1?	No	N/A	Painted X Walk2?	N/A
	X Walk 1 Direction	To NW		X Walk 2 Direction	N/A
N/A	X Walk 1 Width (in)	N/A	N/A	X Walk 2 Width (in)	N/A
	X Walk 1 Slope (%)	3.2		X Walk 2 Slope (%)	N/A
	X Walk 1 X Slope (%)	2.7		X Walk 2 X Slope (%)	N/A
N/A	Ramp inside XWalk1?	N/A	N/A	Ramp inside XWalk2?	N/A

Road Slope (%)	N/A	N/A	Clear Space?	N/A
	Road X Slope (%)	N/A	N/A	Clear Space to XWalk (in)	N/A
N/A	Any Obstructions?	N/A	N/A	Storm Grate/Utility Hazard?	N/A
	Obstruction Type			Storm Grate/Utility Type	
		N/A			N/A
			Yes	Surface Condition? (G/P)	Good
			N/A	Curb Slope (%)	10.5

Possible Solutions:

Remove & Replace Entire Ramp.
