Access Compliance Report

Public Rights-of-Way

(Curb Ramps)

Intersection ID: 10023924	Main Street: CONLAN_CR	Cross Street: N/A	Location: N
ADA ID: 8DD7272ACA95	Ramp Type: Perpendicular	Initial Pass/Fail: Fail	Overall Compliance: No
			Severity Score: 33.75

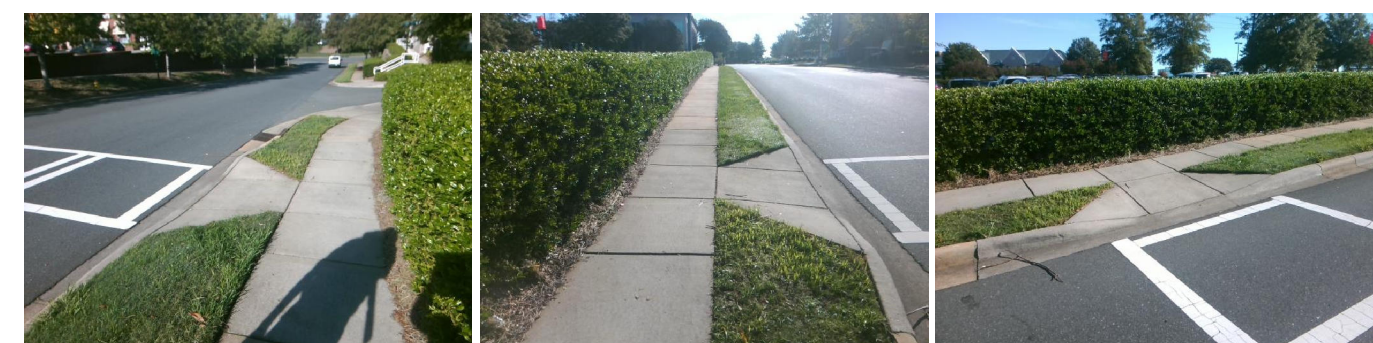
Possible Solutions:		Compliance	Description	Data
	Remove & Replace Entire Ramp.		No	Ramp Length (in)	50.0
			No	Ramp Width (in)	46.0
			N/A	Flare Type LT	N/A
			N/A	Flare Slope LT (%)	N/A
			N/A	Flare Traversable LT?	N/A
			N/A	Landing Length (in)	N/A
			N/A	Landing Width (in)	N/A
			N/A	Landing Slope (%)	N/A
			N/A	Landing X Slope (%)	N/A
<p>Surveyor Notes:</p> <p>N/A</p> <p>PROW/ADA:</p> <p>Not Found, R304.5.1, R304.2.2, R304.5.3</p>			N/A	Flare Type RT	N/A
			N/A	Flare Slope RT (%)	N/A
			N/A	Flare Traversable RT?	N/A
			N/A	DWS Provided?	N/A
			N/A	DWS Contrast?	N/A
			N/A	DWS Length (in)	N/A
			N/A	DWS Full Width?	N/A
			N/A	DWS Offset (in)	N/A
			N/A	Shared Landing?	N/A
			N/A	Gutter Ponding?	N/A
			N/A	Gutter Lip Ht (in)	N/A
			N/A	Painted X Walk1?	Yes
				X Walk 1 Direction	To SW
			N/A	X Walk 1 Width (in)	104.0
				X Walk 1 Slope (%)	4.9

X Walk 1 X Slope (%)	6.1
			N/A	Ramp inside XWalk1?	Yes
			N/A	Road Slope (%)	N/A
			N/A	Road X Slope (%)	N/A
			N/A	Any Obstructions?	N/A
Total Cost:		\$ 1850.00		Obstruction Type	
			N/A		N/A
			Yes	Surface Condition? (G/P)	Good
