Access Compliance Report

Public Rights-of-Way

(Curb Ramps)

Intersection ID: 30431	Main Street: CEDAR_ROCK_DR	Cross Street: ELM_BEND_DR	Location: SE
ADA ID: 8E61623B5DB4	Ramp Type: PerpDiag	Initial Pass/Fail: Fail	Overall Compliance: No
Severity Score: 8.75			
Codes/Mitigation Info/Possible Solution		Field Measurements/Component Compliance

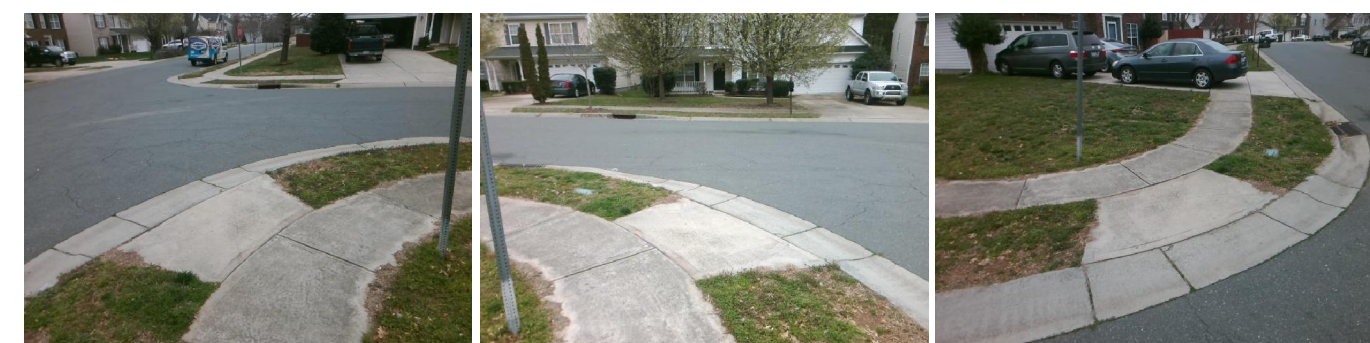
Compliance	Description	Data	Compliance	Description	Data
N/A	Ramp Length (in)	48.0	Yes	Ramp Slope (%)	5.9
No	Ramp Width (in)	43.0	Yes	Ramp XSlope (%)	0.6
N/A	Flare Type LT	N/A	N/A	Flare Type RT	N/A
N/A	Flare Slope LT (%)	N/A	N/A	Flare Slope RT (%)	N/A
N/A	Flare Traversable LT?	N/A	N/A	Flare Traversable RT?	N/A
N/A	Landing Length (in)	N/A	N/A	DWS Provided?	N/A
N/A	Landing Width (in)	N/A	N/A	DWS Contrast?	N/A
N/A	Landing Slope (%)	N/A	N/A	DWS Length (in)	N/A
N/A	Landing X Slope (%)	N/A	N/A	DWS Full Width?	N/A
N/A	Landing Curb? (Y/N)	N/A	N/A	DWS Offset (in)	N/A
N/A	Shared Landing?	N/A			
N/A	Gutter Ponding?	N/A	N/A	Gutter Slope (%)	N/A
N/A	Gutter Lip Ht (in)	N/A	N/A	Gutter X Slope (%)	N/A
N/A	Painted X Walk1?	No	N/A	Painted X Walk2?	No
	X Walk 1 Direction	To NW		X Walk 2 Direction	To SW
N/A	X Walk 1 Width (in)	N/A	N/A	X Walk 2 Width (in)	N/A
	X Walk 1 Slope (%)	1.3		X Walk 2 Slope (%)	1.2
	X Walk 1 X Slope (%)	0.4		X Walk 2 X Slope (%)	0.2

N/A	Ramp inside XWalk1?	N/A	N/A	Ramp inside XWalk2?	N/A
	Road Slope (%)	1.0	N/A	Clear Space?	N/A
	Road X Slope (%)	1.7	N/A	Clear Space to XWalk (in)	N/A
N/A	Any Obstructions?	N/A	N/A	Storm Grate/Utility Hazard?	N/A
	Obstruction Type			Storm Grate/Utility Type	
		N/A			N/A
			Yes	Surface Condition? (G/P)	Good

Remove & Replace Curb Ramp With Two New Directional Ramps or Equivalent.
