Intersection ID: 10041968	Main Street: WINDSOR_CASTLE_LN	Cross Street: N/A	Location:	W
ADA ID: 8F4D87FC8BE0	Ramp Type: Perpendicular Diagonal	Initial Pass/Fail: Fail	Overall Compliance: No	Severity Score: 18.75

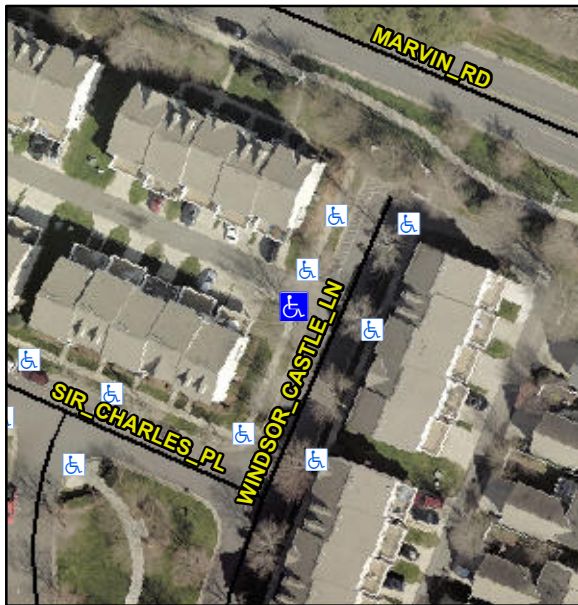
Compliance	Description	Data	Compliance	Description	Data
N/A	Ramp Length (in)	76.0	Yes	Ramp Slope (%)	7.2
No	Ramp Width (in)	32.0	Yes	Ramp XSlope (%)	2.5
N/A	Flare Type LT	N/A	N/A	Flare Type RT	N/A
N/A	Flare Slope LT (%)	N/A	N/A	Flare Slope RT (%)	N/A
N/A	Flare Traversable LT?	N/A	N/A	Flare Traversable RT?	N/A
N/A	Landing Length (in)	N/A	N/A	DWS Provided?	N/A
N/A	Landing Width (in)	N/A	N/A	DWS Contrast?	N/A
N/A	Landing Slope (%)	N/A	N/A	DWS Length (in)	N/A
N/A	Landing X Slope (%)	N/A	N/A	DWS Full Width?	N/A
N/A	Landing Curb? (Y/N)	N/A	N/A	DWS Offset (in)	N/A
N/A	Shared Landing?	N/A			
N/A	Gutter Ponding?	N/A	N/A	Gutter Slope (%)	N/A
N/A	Gutter Lip Ht (in)	N/A	N/A	Gutter X Slope (%)	N/A
N/A	Painted X Walk1?	No	N/A	Painted X Walk2?	No
	X Walk 1 Direction	To SE		X Walk 2 Direction	To NE
N/A	X Walk 1 Width (in)	N/A	N/A	X Walk 2 Width (in)	N/A
	X Walk 1 Slope (%)	1.4		X Walk 2 Slope (%)	1.3
	X Walk 1 X Slope (%)	3.9		X Walk 2 X Slope (%)	1.0

**Remove & Replace Curb Ramp With Two New Directional Ramps or Equivalent.**
