Access Compliance Report

Public Rights-of-Way

(Curb Ramps)

Intersection ID: 10242	Main Street: KING_RD	Cross Street: LINDA_LAKE_DR	Location: SW
ADA ID: 8F6945256A41	Ramp Type: Combination1	Initial Pass/Fail: Fail	Overall Compliance: No
		Severity Score: 10

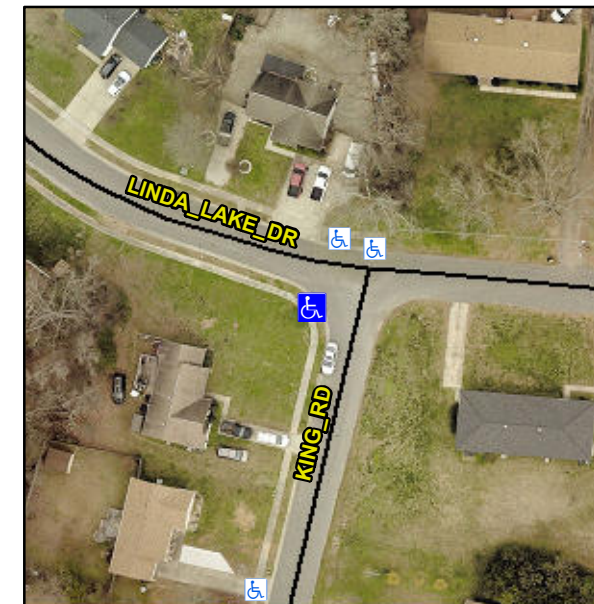
RT RP < 5%

Not Found, R304.5.1, R304.5.1, R304.5.3

Compliance	Description	Data	Compliance	Description	Data
N/A	Ramp Length LT (in)	41.0	N/A	Ramp Length RT (in)	32.0
No	Ramp Width LT (in)	46.0	No	Ramp Width RT (in)	43.0
Yes	Ramp Slope LT (%)	6.6	Yes	Ramp Slope RT (%)	3.0
No	Ramp XSlope LT (%)	2.3	No	Ramp XSlope RT (%)	2.2
N/A	Ramp Length (in)	49.5	Yes	Ramp Slope (%)	5.3
No	Ramp Width (in)	47.5	Yes	Ramp XSlope (%)	3.4
N/A	Flare Type LT	N/A	N/A	Flare Type RT	N/A
N/A	Flare Slope LT (%)	N/A	N/A	Flare Slope RT (%)	N/A
N/A	Flare Traversable LT?	N/A	N/A	Flare Traversable RT?	N/A
N/A	Landing Length (in)	N/A	N/A	DWS Provided?	N/A
N/A	Landing Width (in)	N/A	N/A	DWS Contrast?	N/A
N/A	Landing Slope (%)	N/A	N/A	DWS Length (in)	N/A
N/A	Landing X Slope (%)	N/A	N/A	DWS Full Width?	N/A
N/A	Landing Curb? (Y/N)	N/A	N/A	DWS Offset (in)	N/A
N/A	Shared Landing?	N/A			
N/A	Gutter Ponding?	N/A	N/A	Gutter Slope (%)	N/A
N/A	Gutter Lip Ht (in)	N/A	N/A	Gutter X Slope (%)	N/A
N/A	Painted X Walk1?	No	N/A	Painted X Walk2?	N/A

Remove & Replace Entire Ramp.
