Access Compliance Report

Public Rights-of-Way

(Curb Ramps)

Intersection ID: 46816	Main Street: CYPRESS_VIEW_DR	Cross Street: ARBOR_VISTA_DR	Location: SW
ADA ID: 91448AF3B22E	Ramp Type: Perp	Initial Pass/Fail: Fail	Overall Compliance: No
Severity Score: 21.25			
Codes/Mitigation Info/Possible Solution		Field Measurements/Component Compliance

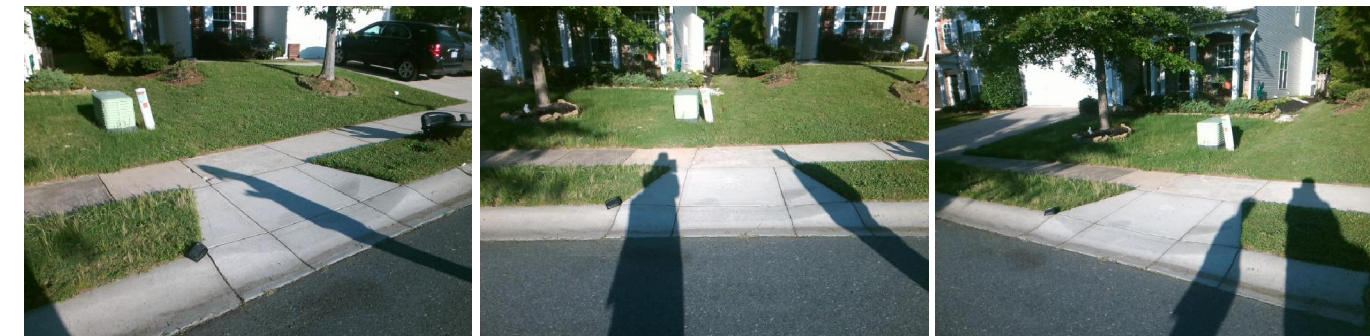
Not Found, R304.5.1, R304.2.2

Compliance	Description	Data	Compliance	Description	Data
N/A	Ramp Length (in)	47.0	No	Ramp Slope (%)	8.6
No	Ramp Width (in)	46.5	Yes	Ramp XSlope (%)	2.0
N/A	Flare Type LT	N/A	N/A	Flare Type RT	N/A
N/A	Flare Slope LT (%)	N/A	N/A	Flare Slope RT (%)	N/A
N/A	Flare Traversable LT?	N/A	N/A	Flare Traversable RT?	N/A
N/A	Landing Length (in)	N/A	N/A	DWS Provided?	N/A
N/A	Landing Width (in)	N/A	N/A	DWS Contrast?	N/A
N/A	Landing Slope (%)	N/A	N/A	DWS Length (in)	N/A
N/A	Landing X Slope (%)	N/A	N/A	DWS Full Width?	N/A
N/A	Landing Curb? (Y/N)	N/A	N/A	DWS Offset (in)	N/A
N/A	Shared Landing?	N/A			
N/A	Gutter Ponding?	N/A	N/A	Gutter Slope (%)	N/A
N/A	Gutter Lip Ht (in)	N/A	N/A	Gutter X Slope (%)	N/A
N/A	Painted X Walk1?	No	N/A	Painted X Walk2?	N/A
	X Walk 1 Direction	To E		X Walk 2 Direction	N/A
N/A	X Walk 1 Width (in)	N/A	N/A	X Walk 2 Width (in)	N/A
	X Walk 1 Slope (%)	2.6		X Walk 2 Slope (%)	N/A
	X Walk 1 X Slope (%)	2.7		X Walk 2 X Slope (%)	N/A

Remove & Replace Entire Ramp.
