# Access Compliance Report

## Public Rights-of-Way

### (Curb Ramps)

| Intersection ID: 45172 | Main Street: ELDON_DR | Cross Street: LINDEN_TREE_LN | Location: SE |

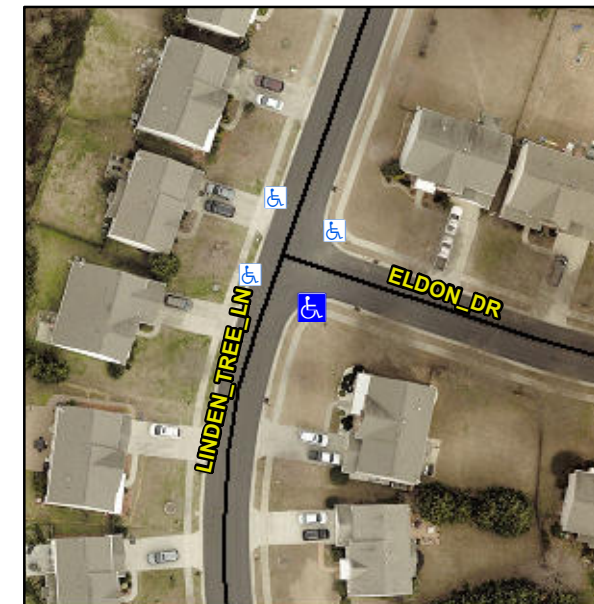
**N/A**

**Not Found, R304.5.3, R305, R304.5.4**

| Compliance | Description | Data | Compliance | Description | Data |
|---|---|---|---|---|---|
| Yes | Ramp Width (in) | 53.0 | No | BlendTrans XSlope (%) | 4.4 |
| Yes | Landing Length (in) | 48.0 | No | DWS Provided? | No |
| No | Landing X Slope (%) | 3.6 | N/A | DWS Full Width? | No |
| Yes | Gutter Ponding? | No | No | Gutter Slope (%) | 5.6 |
| Yes | Gutter Lip Ht (in) | 0.0 | No | Gutter X Slope (%) | 3.3 |

**Remove & Replace Curb Ramp With Two New Directional Ramps or Equivalent. Remove & Replace Gutter.**
