Access Compliance Report

Public Rights-of-Way

(Curb Ramps)

Intersection ID: 50605	Main Street: DENBUR_DR	Cross Street: RHODORA_RD	Location: NE
ADA ID: 9447A2F579AD	Ramp Type: Perp	Initial Pass/Fail: Fail	Overall Compliance: No
Severity Score: 33.75			
Codes/Mitigation Info/Possible Solution		Field Measurements/Component Compliance

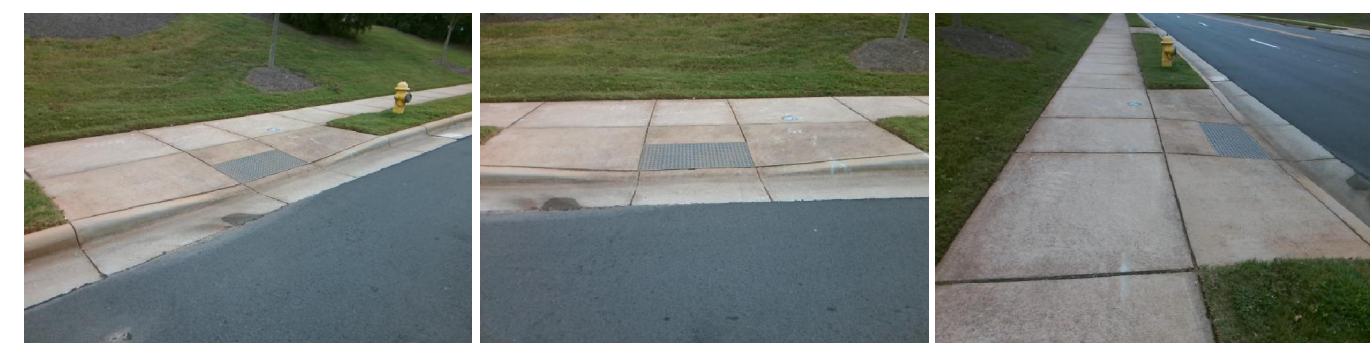
Not Found, R304.5.1, R304.2.2, R304.5.3

Compliance	Description	Data	Compliance	Description	Data
N/A	Ramp Length (in)	48.0	No	Ramp Slope (%)	10.2
No	Ramp Width (in)	47.5	No	Ramp XSlope (%)	5.1
N/A	Flare Type LT	N/A	N/A	Flare Type RT	N/A
N/A	Flare Slope LT (%)	N/A	N/A	Flare Slope RT (%)	N/A
N/A	Flare Traversable LT?	N/A	N/A	Flare Traversable RT?	N/A
N/A	Landing Length (in)	N/A	N/A	DWS Provided?	N/A
N/A	Landing Width (in)	N/A	N/A	DWS Contrast?	N/A
N/A	Landing Slope (%)	N/A	N/A	DWS Length (in)	N/A
N/A	Landing X Slope (%)	N/A	N/A	DWS Full Width?	N/A
N/A	Landing Curb? (Y/N)	N/A	N/A	DWS Offset (in)	N/A
N/A	Shared Landing?	N/A			
N/A	Gutter Ponding?	N/A	N/A	Gutter Slope (%)	N/A
N/A	Gutter Lip Ht (in)	N/A	N/A	Gutter X Slope (%)	N/A
N/A	Painted X Walk1?	No	N/A	Painted X Walk2?	N/A
	X Walk 1 Direction	To W		X Walk 2 Direction	N/A
N/A	X Walk 1 Width (in)	N/A	N/A	X Walk 2 Width (in)	N/A
	X Walk 1 Slope (%)	1.7		X Walk 2 Slope (%)	N/A
	X Walk 1 X Slope (%)	4.7		X Walk 2 X Slope (%)	N/A

N/A	Ramp inside XWalk1?	N/A	N/A	Ramp inside XWalk2?	N/A
	Road Slope (%)	N/A	N/A	Clear Space?	N/A
	Road X Slope (%)	N/A	N/A	Clear Space to XWalk (in)	N/A
N/A	Any Obstructions?	N/A	N/A	Storm Grate/Utility Hazard?	N/A
	Obstruction Type			Storm Grate/Utility Type	
		N/A			N/A
			Yes	Surface Condition? (G/P)	Good

Possible Solutions:

Remove & Replace Entire Ramp.
