Access Compliance Report

Public Rights-of-Way

(Curb Ramps)

| Intersection ID: 14294 | Main Street: EAST_BV | Cross Street: EUCLID_AV | Location: SW |

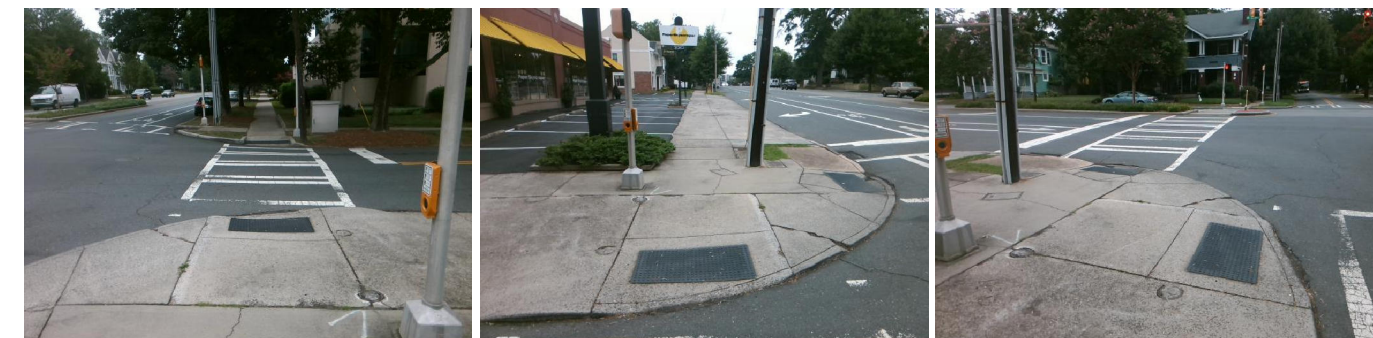
| ADA ID: 94E5C053F6A5 | Ramp Type: Directional1 | Initial Pass/Fail: Fail | Overall Compliance: No |

| Compliance | Description | Data | Compliance | Description | Data |
|---|---|---|---|---|---|
| No | Ramp XSlope (%) | 5.9 | | | |

Possible Solutions:

Remove & Replace Entire Ramp.
