# Access Compliance Report

### (Curb Ramps)

| Intersection ID: 48948 | Main Street: BIRCHLEY_CR | Cross Street: DAVID_JENNINGS_AV | Location: NW |
| ADA ID: 95A7AD70C847 | Ramp Type: Perp | Initial Pass/Fail: Fail | Overall Compliance: No |

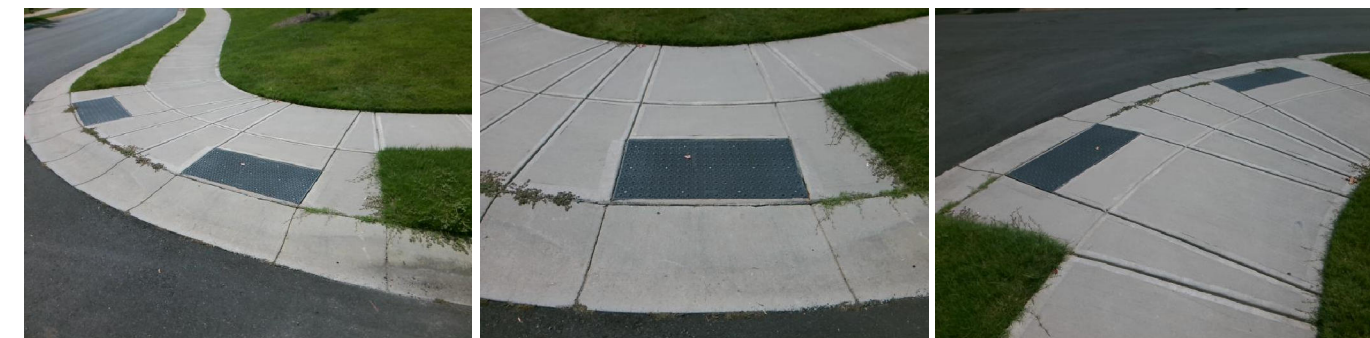
**Not Found, R304.5.1**

| Compliance | Description | Data | Compliance | Description | Data |
|---|---|---|---|---|---|
| No | Ramp Width (in) | 45.5 | Yes | Ramp XSlope (%) | 1.4 |

**Remove & Replace Entire Ramp.**
