Access Compliance Report

Public Rights-of-Way

(Curb Ramps)

Intersection ID: 46816	Main Street: CYPRESS_VIEW_DR	Cross Street: ARBOR_VISTA_DR	Location: SE
ADA ID: 95B9F53B56A8	Ramp Type: PerpDiag	Initial Pass/Fail: Fail	Overall Compliance: No
			Severity Score: 21.25

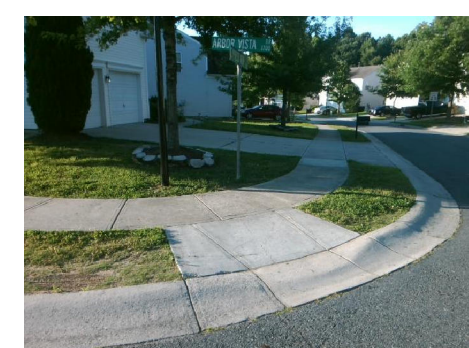
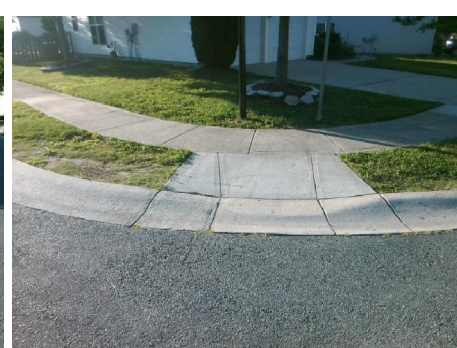
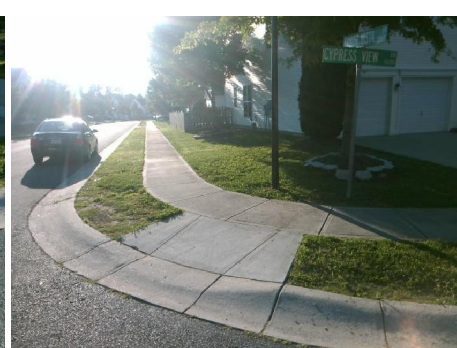
Possible Solutions:		Compliance	Description	Data
	Remove & Replace Curb Ramp With Two New Directional Ramps or Equivalent.		No	Ramp Length (in)	46.0
			No	Ramp Width (in)	39.0
			N/A	Flare Type LT	N/A
			N/A	Flare Slope LT (%)	N/A
			N/A	Flare Traversable LT?	N/A
			N/A	Landing Length (in)	N/A
			N/A	Landing Width (in)	N/A
			N/A	Landing Slope (%)	N/A
			N/A	Landing X Slope (%)	N/A
<p>Surveyor Notes:</p> <p>N/A</p> <p>PROW/ADA:</p> <p>Not Found, R304.5.1, R304.2.2</p>			N/A	Flare Type RT	N/A
			N/A	Flare Slope RT (%)	N/A
			N/A	Flare Traversable RT?	N/A
			N/A	DWS Provided?	N/A
			N/A	DWS Contrast?	N/A
			N/A	DWS Length (in)	N/A
			N/A	DWS Full Width?	N/A
			N/A	DWS Offset (in)	N/A
			N/A	Gutter Ponding?	N/A
			N/A	Gutter Lip Ht (in)	N/A
			No	Painted X Walk1?	No
			To N	X Walk 1 Direction	To W
			N/A	X Walk 1 Width (in)	N/A

2.8	X Walk 1 Slope (%)	2.9
			1.6	X Walk 1 X Slope (%)	2.6
			N/A	Ramp inside XWalk1?	N/A
			0.9	Road Slope (%)	N/A
			3.4	Road X Slope (%)	N/A
			N/A	Any Obstructions?	N/A
				Obstruction Type	
Total Cost:			\$ 3200.00		
			N/A		N/A
			Yes	Surface Condition? (G/P)	Good
