Access Compliance Report

Public Rights-of-Way

(Curb Ramps)

Intersection ID: 2765	Main Street: BEAUVISTA_DR	Cross Street: HICKORY_COVE_LN	Location: SE
ADA ID: 99B1DC2F2B70	Ramp Type: PerpDiag	Initial Pass/Fail: Fail	Overall Compliance: No
			Severity Score: 33.75

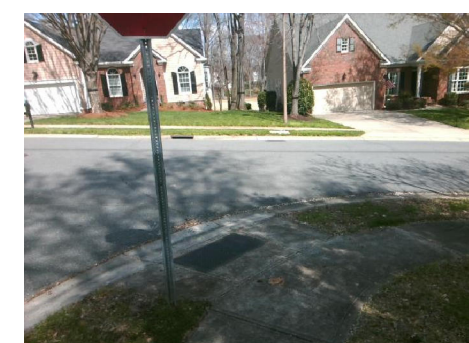
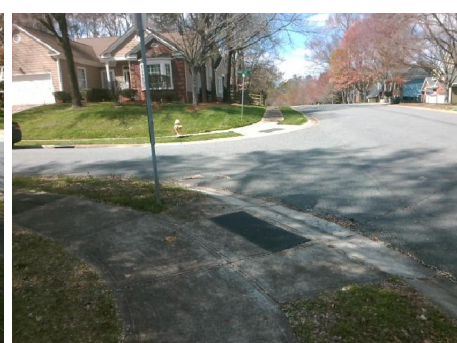
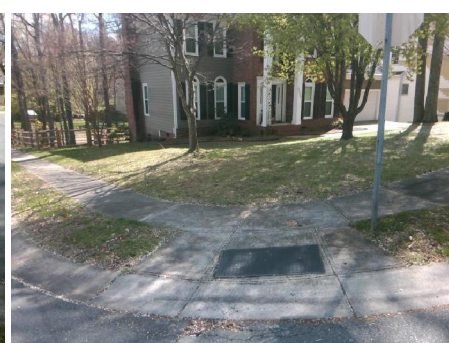
Possible Solutions:		Compliance	Description	Data
	Remove & Replace Curb Ramp With Two New Directional Ramps or Equivalent.		Yes	Ramp Length (in)	5.3
			No	Ramp Width (in)	10.2
			N/A	Flare Type LT	N/A
			N/A	Flare Slope LT (%)	N/A
			N/A	Flare Traversable LT?	N/A
			N/A	Landing Length (in)	N/A
			N/A	Landing Width (in)	N/A
			N/A	Landing Slope (%)	N/A
			N/A	Landing X Slope (%)	N/A
<p>Surveyor Notes:</p> <p>N/A</p> <p>PROW/ADA:</p> <p>Not Found, R304.5.1, R304.5.3</p>			N/A	Flare Type RT	N/A
			N/A	Flare Slope RT (%)	N/A
			N/A	Flare Traversable RT?	N/A
			N/A	DWS Provided?	N/A
			N/A	DWS Contrast?	N/A
			N/A	DWS Length (in)	N/A
			N/A	DWS Full Width?	N/A
			N/A	DWS Offset (in)	N/A
			N/A	Gutter Ponding?	N/A
			N/A	Gutter Lip Ht (in)	N/A
			No	Painted X Walk1?	No
				X Walk 1 Direction	To N
			N/A	X Walk 1 Width (in)	N/A

7.5	X Walk 1 Slope (%)	9.6
			7.8	X Walk 1 X Slope (%)	3.0
			N/A	Ramp inside XWalk1?	N/A
			8.2	Road Slope (%)	N/A
			6.0	Road X Slope (%)	N/A
			N/A	Any Obstructions?	N/A
				Obstruction Type	
Total Cost: \$ 3200.00			N/A	Storm Grate/Utility Hazard?	N/A
			N/A	Storm Grate/Utility Type	N/A
			Yes	Surface Condition? (G/P)	Good
