Access Compliance Report

Public Rights-of-Way

(Curb Ramps)

Intersection ID: 8697	Main Street: HOLLAND_AV	Cross Street: ISENHOUR_ST	Location: NW
ADA ID: 99F019608B3A	Ramp Type: PerpDiag	Initial Pass/Fail: Fail	Overall Compliance: No
		Severity Score: 33.75

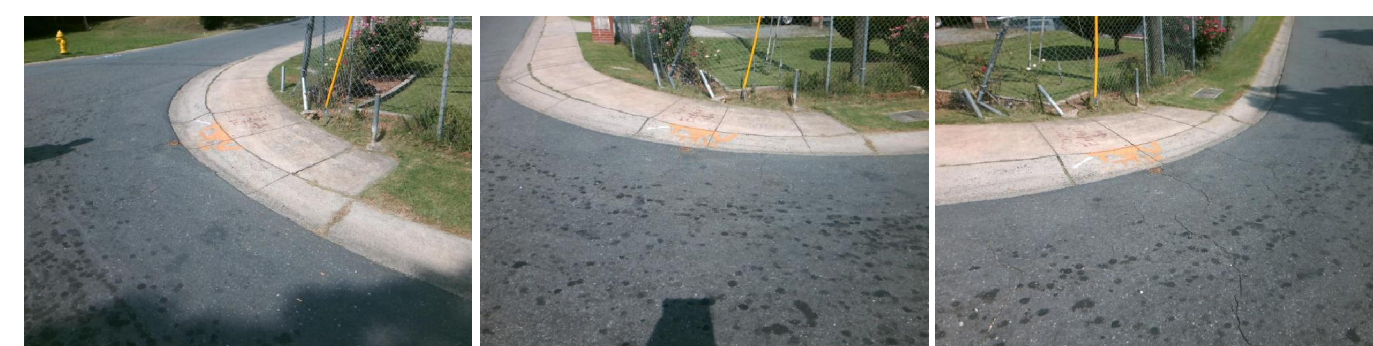
N/A	Painted X Walk1?	No	N/A	Painted X Walk2?	No
			X Walk 1 Direction	To S		X Walk 2 Direction	To E
		N/A	X Walk 1 Width (in)	N/A	N/A	X Walk 2 Width (in)	N/A
			X Walk 1 Slope (%)	N/A		X Walk 2 Slope (%)	1.5
			X Walk 1 X Slope (%)	N/A		X Walk 2 X Slope (%)	10.1
		N/A	Ramp inside XWalk1?	N/A	N/A	Ramp inside XWalk2?	N/A
			Road Slope (%)	N/A	N/A	Clear Space?	N/A
			Road X Slope (%)	N/A	N/A	Clear Space to XWalk (in)	N/A
		N/A	Any Obstructions?	N/A	N/A	Storm Grate/Utility Hazard?	N/A
			Obstruction Type			Storm Grate/Utility Type	
					N/A		N/A
					Yes	Surface Condition? (G/P)	Good
	Total Cost:		\$	3200.00

Possible Solutions:						
	Remove & Replace Curb Ramp With Two New Directional Ramps or Equivalent.	N/A	Ramp Length (in)	47.0	Yes	Ramp Slope (%)	5.0
		No	Ramp Width (in)	38.0	No	Ramp XSlope (%)	13.3
		N/A	Flare Type LT	N/A	N/A	Flare Type RT	N/A
		N/A	Flare Slope LT (%)	N/A	N/A	Flare Slope RT (%)	N/A
		N/A	Flare Traversable LT?	N/A	N/A	Flare Traversable RT?	N/A
		N/A	Landing Length (in)	N/A	N/A	DWS Provided?	N/A
		N/A	Landing Width (in)	N/A	N/A	DWS Contrast?	N/A
		N/A	Landing Slope (%)	N/A	N/A	DWS Length (in)	N/A
		N/A	Landing X Slope (%)	N/A	N/A	DWS Full Width?	N/A
<p>Surveyor Notes:</p> <p>N/A</p> <p>PROW/ADA:</p> <p>Not Found, R304.5.1, R304.5.3</p>		N/A	Landing Curb? (Y/N)	N/A	N/A	DWS Offset (in)	N/A
		N/A	Shared Landing?	N/A			
		N/A	Gutter Ponding?	N/A	N/A	Gutter Slope (%)	N/A
		N/A	Gutter Lip Ht (in)	N/A	N/A	Gutter X Slope (%)	N/A
