# Access Compliance Report

## Public Rights-of-Way (Curb Ramps)

| Intersection ID: 31526 | Main Street: WILGROVE WAY DR | Cross Street: CARLEEN WAY DR | Location: | N |
| ADA ID: 9B13DB8E5F10 | Ramp Type: BlendTrans1 | Initial Pass/Fail: Fail | Overall Compliance: No | Severity Score: 8.75 |

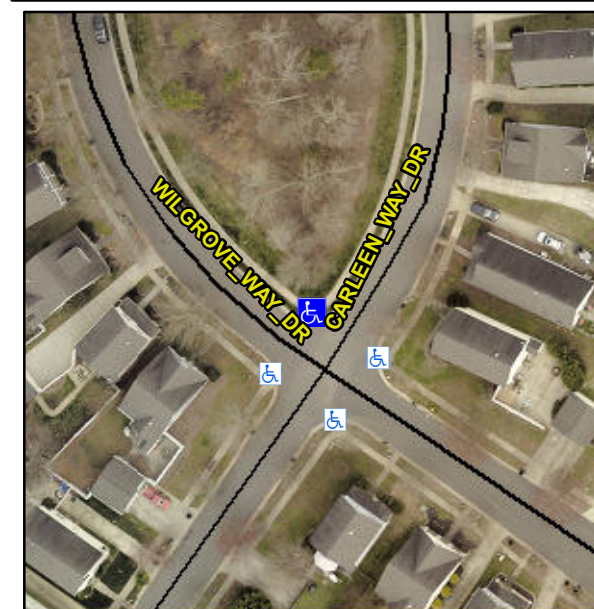
**Not Found, R304.5.1**

| Compliance | Description | Data | Compliance | Description | Data |
|---|---|---|---|---|---|
| No | Ramp Width (in) | 42.5 | Yes | BlendTrans XSlope (%) | 0.4 |

**Remove & Replace Curb Ramp With Two New Directional Ramps or Equivalent.**
