Access Compliance Report

Public Rights-of-Way

| Intersection ID: 13099 | Main Street: E_TRADE_ST | Cross Street: S_MCDOWELL_ST | Location: W |
| ADA ID: 9C510ED9143F | Ramp Type: Para | Initial Pass/Fail: Fail | Overall Compliance: No |

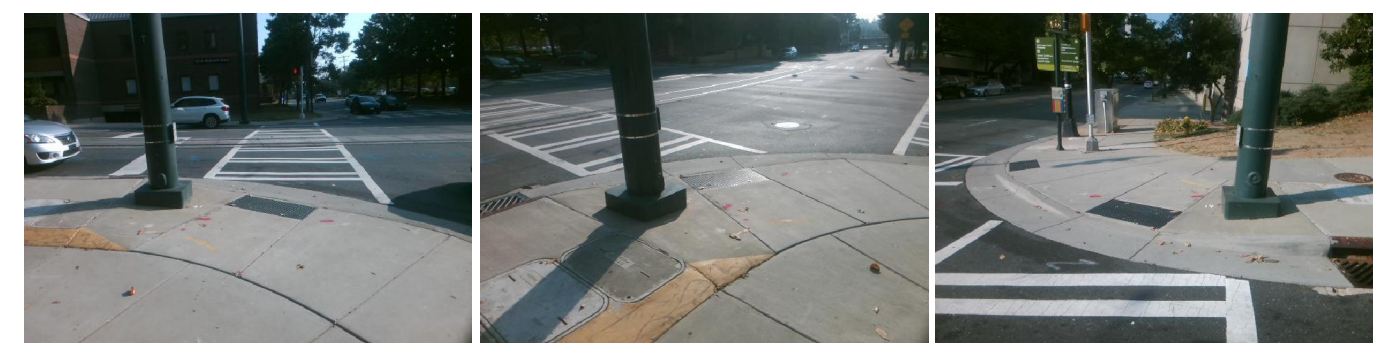
TRAFFIC SIGNAL POLE OBS RT RAMP

| Compliance | Description | Data | Compliance | Description | Data |
|---|---|---|---|---|---|
| Yes | Ramp Slope LT (%) | 5.5 | No | Ramp Slope RT (%) | 12.9 |

Remove & Replace Entire Ramp.
