Access Compliance Report

Public Rights-of-Way

(Curb Ramps)

Intersection ID: 6598	Main Street: CATHEY_RD	Cross Street: PECANWOOD_RD	Location: SE
ADA ID: 9D28660F032D	Ramp Type: Perp	Initial Pass/Fail: Fail	Overall Compliance: No
			Severity Score: 33.75

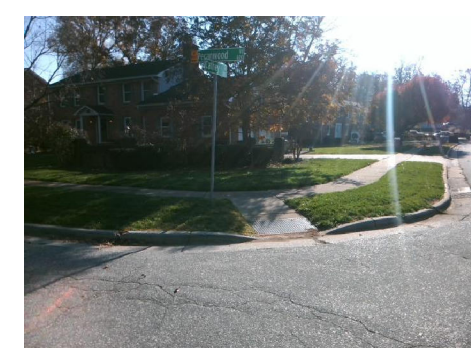
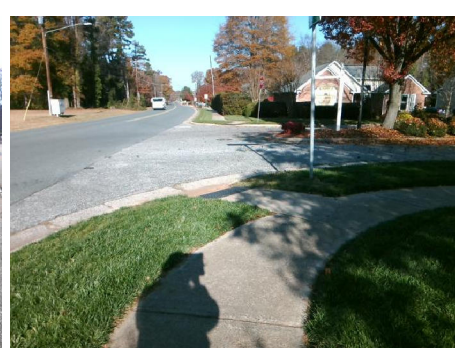
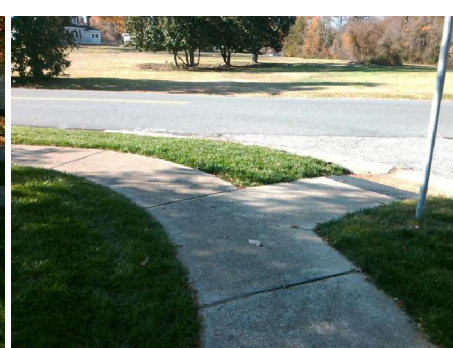
Possible Solutions:		Compliance	Description	Data
	Remove & Replace Entire Ramp.		N/A	Ramp Length (in)	84.0
			No	Ramp Width (in)	44.0
			N/A	Flare Type LT	N/A
			N/A	Flare Slope LT (%)	N/A
			N/A	Flare Traversable LT?	N/A
			N/A	Landing Length (in)	N/A
			N/A	Landing Width (in)	N/A
			N/A	Landing Slope (%)	N/A
			N/A	Landing X Slope (%)	N/A
<p>Surveyor Notes:</p> <p>N/A</p> <p>PROW/ADA:</p> <p>Not Found, R304.5.1, R304.2.2</p>			N/A	Flare Type RT	N/A
			N/A	Flare Slope RT (%)	N/A
			N/A	Flare Traversable RT?	N/A
			N/A	DWS Provided?	N/A
			N/A	DWS Contrast?	N/A
			N/A	DWS Length (in)	N/A
			N/A	DWS Full Width?	N/A
			N/A	DWS Offset (in)	N/A
			N/A	Gutter Ponding?	Yes
			N/A	Gutter Lip Ht (in)	N/A
<p>Total Cost:</p> <p>\$ 1850.00</p>			N/A	Painted X Walk1?	No
				X Walk 1 Direction	To NW
			N/A	X Walk 1 Width (in)	N/A
				X Walk 1 Slope (%)	3.6

X Walk 1 X Slope (%)	2.4
			N/A	Ramp inside XWalk1?	N/A
				Road Slope (%)	N/A
				Road X Slope (%)	N/A
			N/A	Any Obstructions?	N/A
				Obstruction Type	
			N/A	Storm Grate/Utility Hazard?	N/A
			N/A	Storm Grate/Utility Type	
			N/A	Surface Condition? (G/P)	Good
