Access Compliance Report

Public Rights-of-Way

| Intersection ID: 11830 | Main Street: E_13TH_ST | Cross Street: N_CALDWELL_ST | Location: W |
| ADA ID: 9DF51958422D | Ramp Type: Perp | Initial Pass/Fail: Fail | Overall Compliance: No |

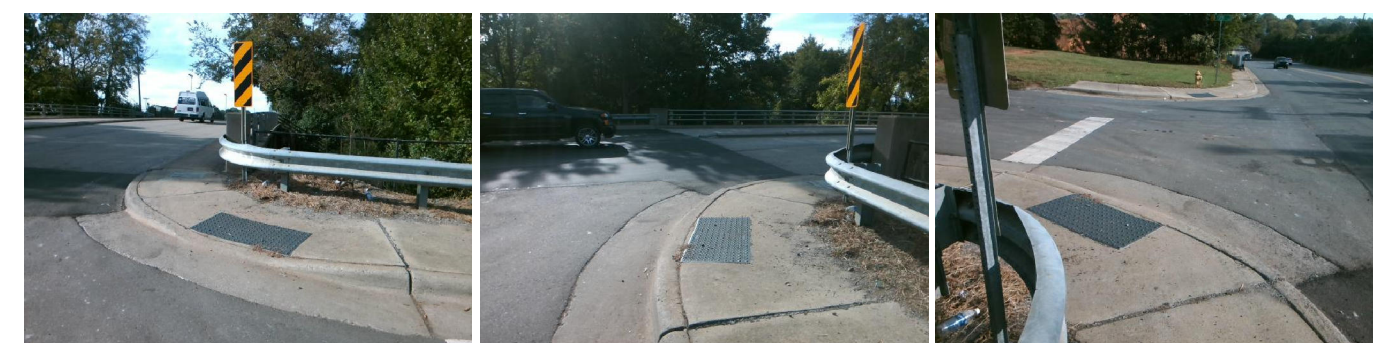
| Severity Score: 22.5 | | | |

Not Found, R304.5.1, R304.2.2, R304.5.3

| Compliance | Description | Data | Compliance | Description | Data |
|---|---|---|---|---|---|
| N/A | Ramp Length (in) | 56.0 | No | Ramp Slope (%) | 10.0 |
| No | Ramp Width (in) | 42.0 | No | Ramp XSlope (%) | 3.1 |

Remove & Replace Entire Ramp.
