Access Compliance Report

Public Rights-of-Way

(Curb Ramps)

Intersection ID: 8474	Main Street: ASBURY_AV	Cross Street: UPPER_ASBURY_AV	Location: E
ADA ID: 9FC8C71E23DC	Ramp Type: Perp	Initial Pass/Fail: Fail	Overall Compliance: No
			Severity Score: 21.25

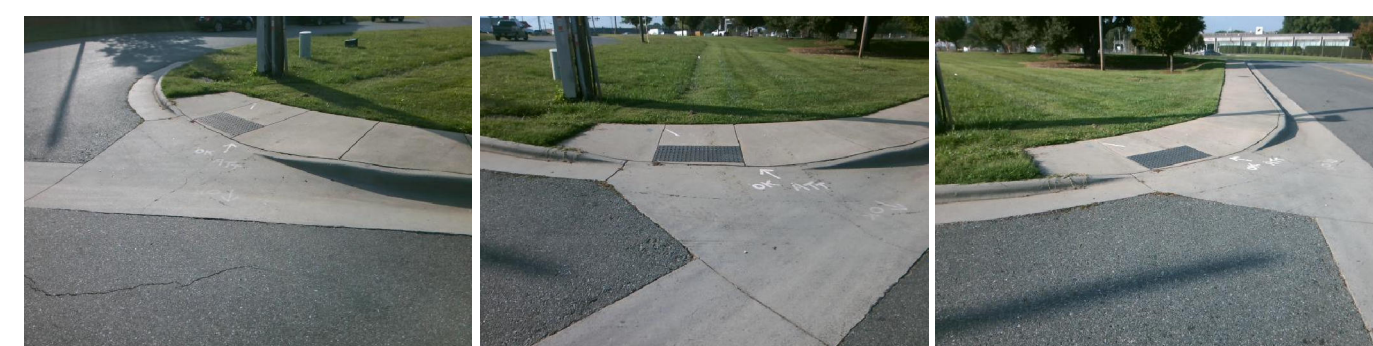
Possible Solutions:		Compliance	Description	Data
	Remove & Replace Entire Ramp.		No	Ramp Length (in)	67.5
			No	Ramp Width (in)	47.5
			N/A	Flare Type LT	N/A
			N/A	Flare Slope LT (%)	N/A
			N/A	Flare Traversable LT?	N/A
			N/A	Landing Length (in)	N/A
			N/A	Landing Width (in)	N/A
			N/A	Landing Slope (%)	N/A
			N/A	Landing X Slope (%)	N/A
<p>Surveyor Notes:</p> <p>N/A</p> <p>PROW/ADA:</p> <p>R304.5.1, R304.2.2</p>			N/A	Flare Type RT	N/A
			N/A	Flare Slope RT (%)	N/A
			N/A	Flare Traversable RT?	N/A
			N/A	DWS Provided?	N/A
			N/A	DWS Contrast?	N/A
			N/A	DWS Length (in)	N/A
			N/A	DWS Full Width?	N/A
			N/A	DWS Offset (in)	N/A
			N/A	Gutter Ponding?	N/A
			N/A	Gutter Lip Ht (in)	N/A
			No	Painted X Walk1?	N/A
			To NW	X Walk 1 Direction	N/A
			N/A	X Walk 1 Width (in)	N/A

5.4	X Walk 1 Slope (%)	N/A
			2.7	X Walk 1 X Slope (%)	N/A
			N/A	Ramp inside XWalk1?	N/A
			N/A	Road Slope (%)	N/A
			N/A	Road X Slope (%)	N/A
			N/A	Any Obstructions?	N/A
				Obstruction Type	N/A
Total Cost: \$ 1850.00			N/A	Storm Grate/Utility Hazard?	N/A
			N/A	Storm Grate/Utility Type	N/A
			Yes	Surface Condition? (G/P)	Good
