# Access Compliance Report

## Public Rights-of-Way (Curb Ramps)

| Intersection ID: 53350 | Main Street: SAPPHIRE_HILL_LN | Cross Street: LOST_CANYON_WY | Location: W |
| ADA ID: A040A1A1B7C7 | Ramp Type: BlendTrans1 | Initial Pass/Fail: Fail | Overall Compliance: No |

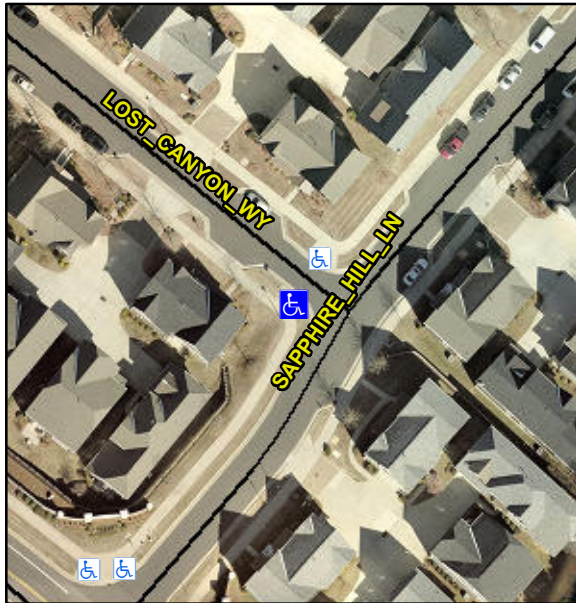
**Not Found, R304.5.3**

| Compliance | Description | Data | Compliance | Description | Data |
|---|---|---|---|---|---|
| Yes | Ramp Width (in) | 60.0 | No | BlendTrans XSlope (%) | 7.9 |

**Remove & Replace Curb Ramp With Two New Directional Ramps or Equivalent.**
