Access Compliance Report

Public Rights-of-Way

(Curb Ramps)

| Intersection ID: 2684 | Main Street: CARDINAL_POINT_RD | Cross Street: SUMMERGOLD_WY | Location: SW |

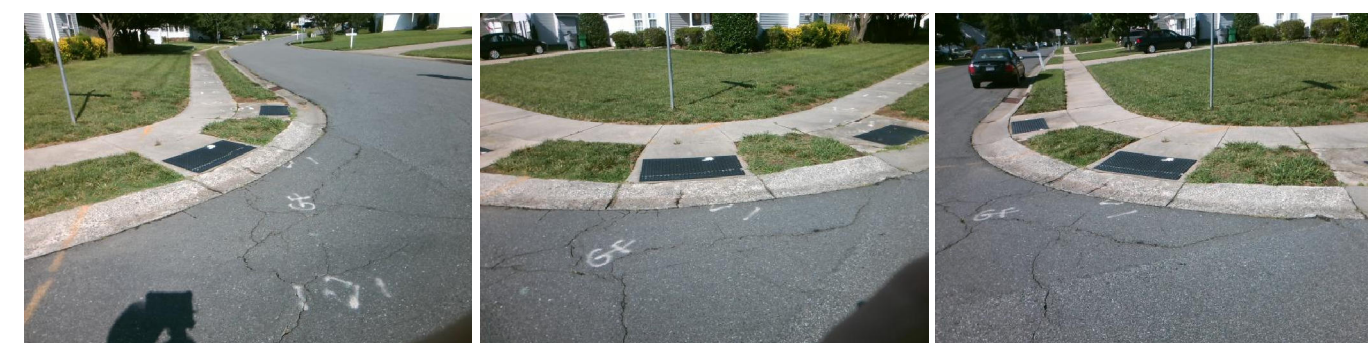
| ADA ID: A0B6E9387AEC | Ramp Type: Perp | Initial Pass/Fail: Fail | Overall Compliance: No |

Not Found, R304.2.2

| Compliance | Description | Data | Compliance | Description | Data |
|---|---|---|---|---|---|
| N/A | Ramp Length (in) | 49.0 | No | Ramp Slope (%) | 9.1 |

Remove & Replace Entire Ramp.
