# Access Compliance Report

## Public Rights-of-Way

| Intersection ID: 50599 | Main Street: HEARTLEAF_RD | Cross Street: STREAM_ORCHID_LN | Location: NW |
| ADA ID: A188AF3B90B2 | Ramp Type: Perp | Initial Pass/Fail: Fail | Overall Compliance: No |

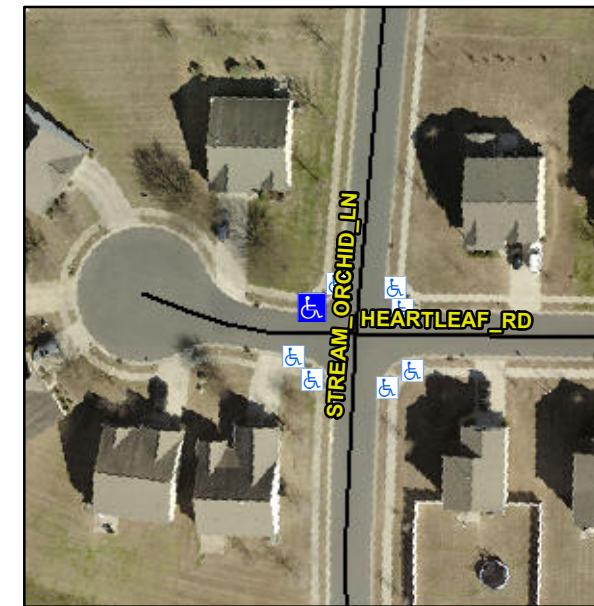
**Not Found, R304.5.3**

| Compliance | Description | Data | Compliance | Description | Data |
|---|---|---|---|---|---|
| Yes | Ramp Width (in) | 48.0 | No | Ramp XSlope (%) | 4.5 |

**Remove & Replace Entire Ramp.**
