Access Compliance Report

Public Rights-of-Way

(Curb Ramps)

Intersection ID: 21262	Main Street: CARMEL_RD	Cross Street: PELLYN_WOOD_DR	Location: NE
ADA ID: A1EDB0032D92	Ramp Type: PerpDiag	Initial Pass/Fail: Fail	Overall Compliance: No
		Severity Score: 37.5

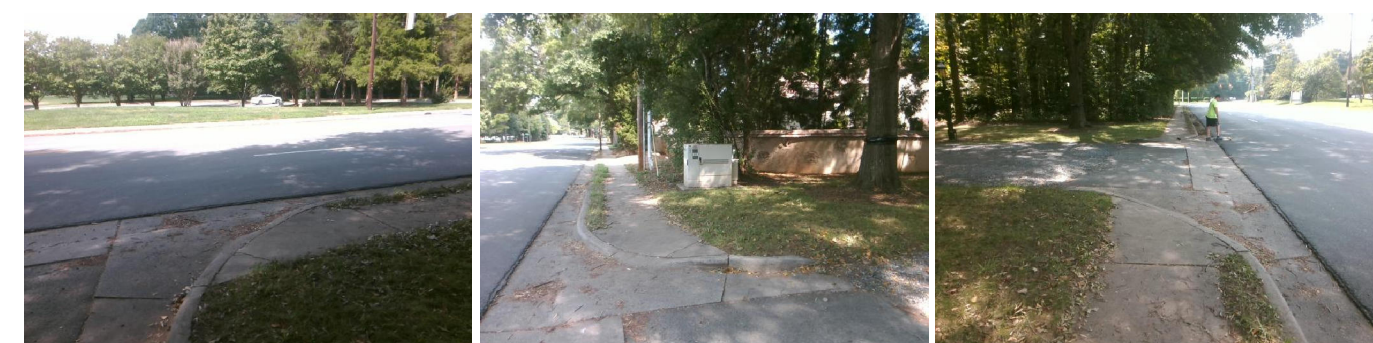
3.1	X Walk 1 Slope (%)	3.4
			0.2	X Walk 1 X Slope (%)	4.5
			N/A	Ramp inside XWalk1?	N/A
			5.0	Road Slope (%)	N/A
			0.2	Road X Slope (%)	N/A
			N/A	Any Obstructions?	N/A
				Obstruction Type	
Total Cost: \$ 3200.00			N/A	Storm Grate/Utility Hazard?	N/A
			N/A	Storm Grate/Utility Type	N/A
			Yes	Surface Condition? (G/P)	Good

Possible Solutions:		Compliance	Description	Data
	Remove & Replace Curb Ramp With Two New Directional Ramps or Equivalent.		No	Ramp Length (in)	48.0
			Yes	Ramp Width (in)	48.0
			N/A	Flare Type LT	N/A
			N/A	Flare Slope LT (%)	N/A
			N/A	Flare Traversable LT?	N/A
			N/A	Landing Length (in)	N/A
			N/A	Landing Width (in)	N/A
			N/A	Landing Slope (%)	N/A
			N/A	Landing X Slope (%)	N/A
<p>Surveyor Notes:</p> <p>N/A</p> <p>PROW/ADA:</p> <p>Not Found, R304.2.2, R304.5.3</p>			N/A	Flare Type RT	N/A
			N/A	Flare Slope RT (%)	N/A
			N/A	Flare Traversable RT?	N/A
			N/A	DWS Provided?	N/A
			N/A	DWS Contrast?	N/A
			N/A	DWS Length (in)	N/A
			N/A	DWS Full Width?	N/A
			N/A	DWS Offset (in)	N/A
			N/A	Gutter Ponding?	N/A
			N/A	Gutter Lip Ht (in)	N/A
			No	Painted X Walk1?	No
				X Walk 1 Direction	To NW
			N/A	X Walk 1 Width (in)	N/A
