# Access Compliance Report

## Public Rights-of-Way

| Intersection ID: 13369 | Main Street: WEST_BV | Cross Street: I-77 | Location: NW |
| ADA ID: A35461502FE8 | Ramp Type: ParaDiag | Initial Pass/Fail: Fail | Overall Compliance: No |

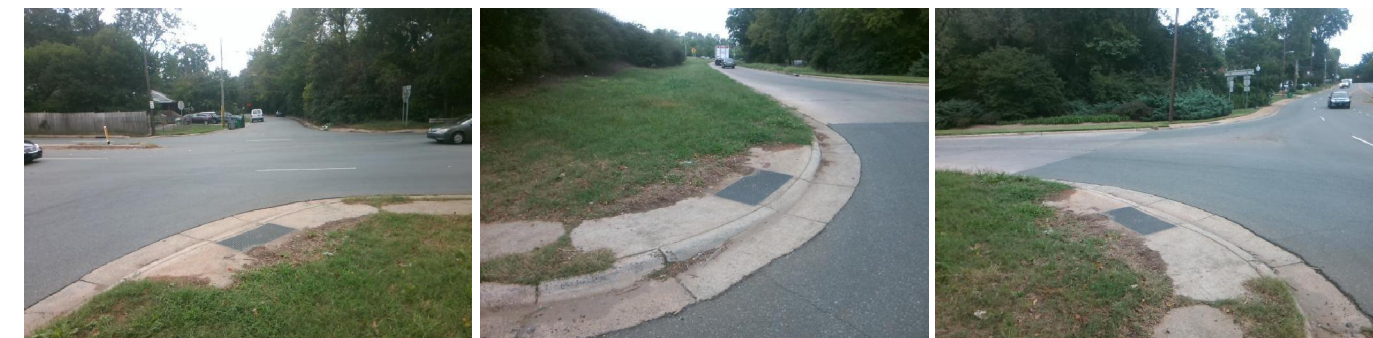
**R304.5.1, R304.3.2**

| Compliance | Description | Data | Compliance | Description | Data |
|---|---|---|---|---|---|
| N/A | Ramp Width LT (in) | N/A | No | Ramp Width RT (in) | 40.0 |
| N/A | Ramp Slope LT (%) | N/A | No | Ramp Slope RT (%) | 10.7 |

**Remove & Replace Curb Ramp With Two New Directional Ramps or Equivalent.**
