Access Compliance Report

Public Rights-of-Way

(Curb Ramps)

| Intersection ID: 17138 | Main Street: IDLEWILD_RD | Cross Street: PINEY_GROVE_RD | Location: SW |

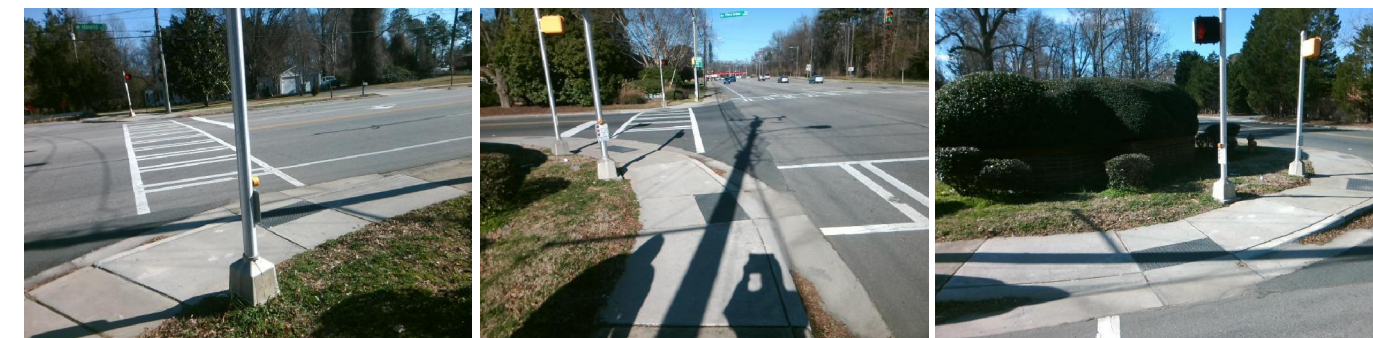
LT RP < 5%

| Compliance | Description | Data | Compliance | Description | Data |
|---|---|---|---|---|---|
| Yes | Ramp Slope LT (%) | 3.5 | No | Ramp Slope RT (%) | 8.5 |
| No | Ramp XSlope LT (%) | 2.6 | Yes | Ramp XSlope RT (%) | 0.1 |

Remove & Replace Entire Ramp.
