Access Compliance Report

Public Rights-of-Way

(Curb Ramps)

| Intersection ID: 21797 | Main Street: GALLERIA_BV | Cross Street: MONROE_RD | Location: SE |

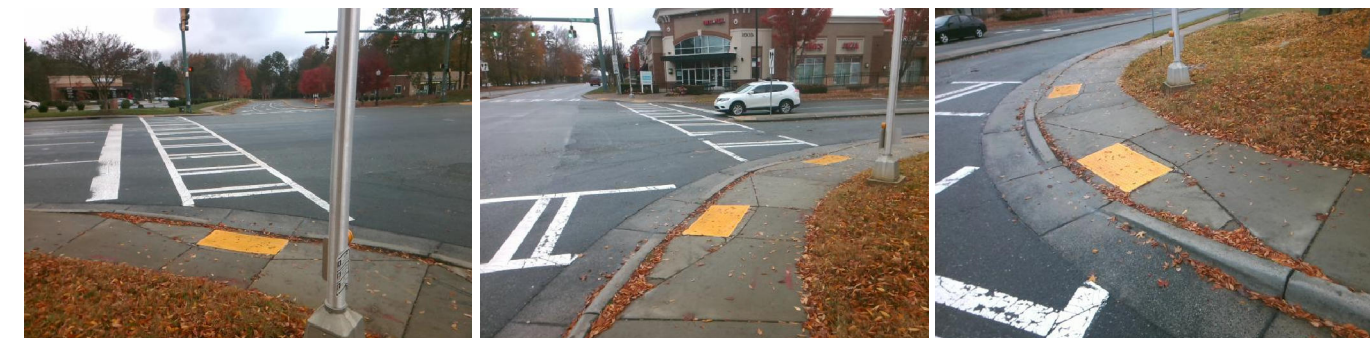
R304.5.1, R304.2.2, R304.5.3

| Compliance | Description | Data | Compliance | Description | Data |
|---|---|---|---|---|---|
| N/A | Ramp Length (in) | 37.0 | No | Ramp Slope (%) | 10.9 |
| No | Ramp Width (in) | 44.0 | No | Ramp XSlope (%) | 3.3 |

Remove & Replace Entire Ramp.
