Access Compliance Report

Public Rights-of-Way

(Curb Ramps)

Intersection ID: 8521	Main Street: HILDEBRAND_ST	Cross Street: MARIBEL_AV	Location: NE
ADA ID: A90C83A27C3D	Ramp Type: Perp	Initial Pass/Fail: Fail	Overall Compliance: No
			Severity Score: 33.75

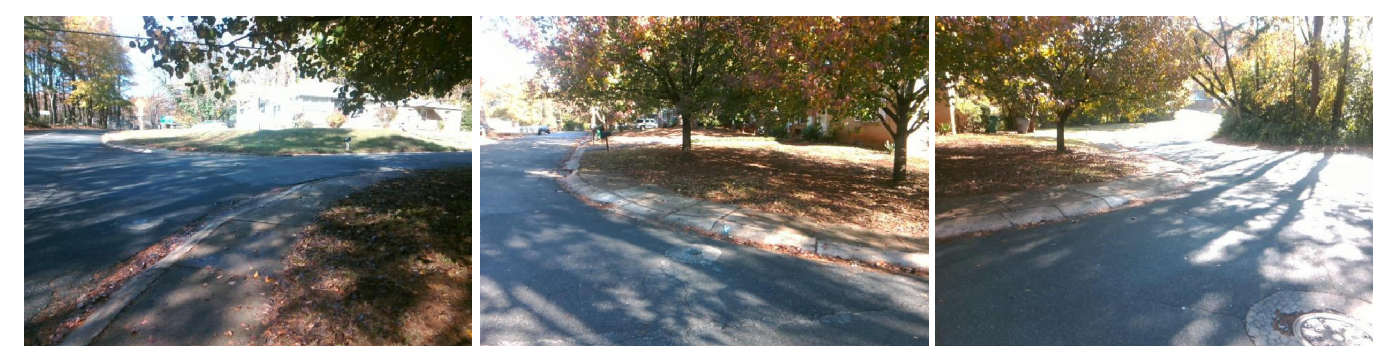
Possible Solutions:		Compliance			Description			Data			
	Remove & Replace Entire Ramp.		N/A	Ramp Length (in)		48.0		Yes	Ramp Slope (%)		7.0	
			No	Ramp Width (in)		40.0		No	Ramp XSlope (%)		10.0	
			N/A	Flare Type LT		N/A		N/A	Flare Type RT		N/A	
			N/A	Flare Slope LT (%)		N/A		N/A	Flare Slope RT (%)		N/A	
			N/A	Flare Traversable LT?		N/A		N/A	Flare Traversable RT?		N/A	
			N/A	Landing Length (in)		N/A		N/A	DWS Provided?		N/A	
			N/A	Landing Width (in)		N/A		N/A	DWS Contrast?		N/A	
			N/A	Landing Slope (%)		N/A		N/A	DWS Length (in)		N/A	
			N/A	Landing X Slope (%)		N/A		N/A	DWS Full Width?		N/A	
Surveyor Notes:	N/A		N/A	Landing Curb? (Y/N)		N/A		N/A	DWS Offset (in)		N/A	
			N/A	Shared Landing?		N/A						
			N/A	Gutter Ponding?		N/A		N/A	Gutter Slope (%)		N/A	
			N/A	Gutter Lip Ht (in)		N/A		N/A	Gutter X Slope (%)		N/A

N/A	Painted X Walk1?		No		N/A	Painted X Walk2?		N/A	
				X Walk 1 Direction		To W			X Walk 2 Direction		N/A	
			N/A	X Walk 1 Width (in)		N/A		N/A	X Walk 2 Width (in)		N/A	
				X Walk 1 Slope (%)		4.4			X Walk 2 Slope (%)		N/A	
				X Walk 1 X Slope (%)		4.0			X Walk 2 X Slope (%)		N/A	
			N/A	Ramp inside XWalk1?		N/A		N/A	Ramp inside XWalk2?		N/A	
PROW/ADA:	Not Found, R304.5.1, R304.5.3			Road Slope (%)		N/A		N/A	Clear Space?		N/A	
				Road X Slope (%)		N/A		N/A	Clear Space to XWalk (in)		N/A	
			N/A	Any Obstructions?		N/A		N/A	Storm Grate/Utility Hazard?		N/A	
				Obstruction Type					Storm Grate/Utility Type			
								N/A			N/A	
								Yes	Surface Condition? (G/P)		Good	
Total Cost:			\$	1850.00
